**SITE 4**

PAGE 12 OF 22

## Video Inspection Master Report

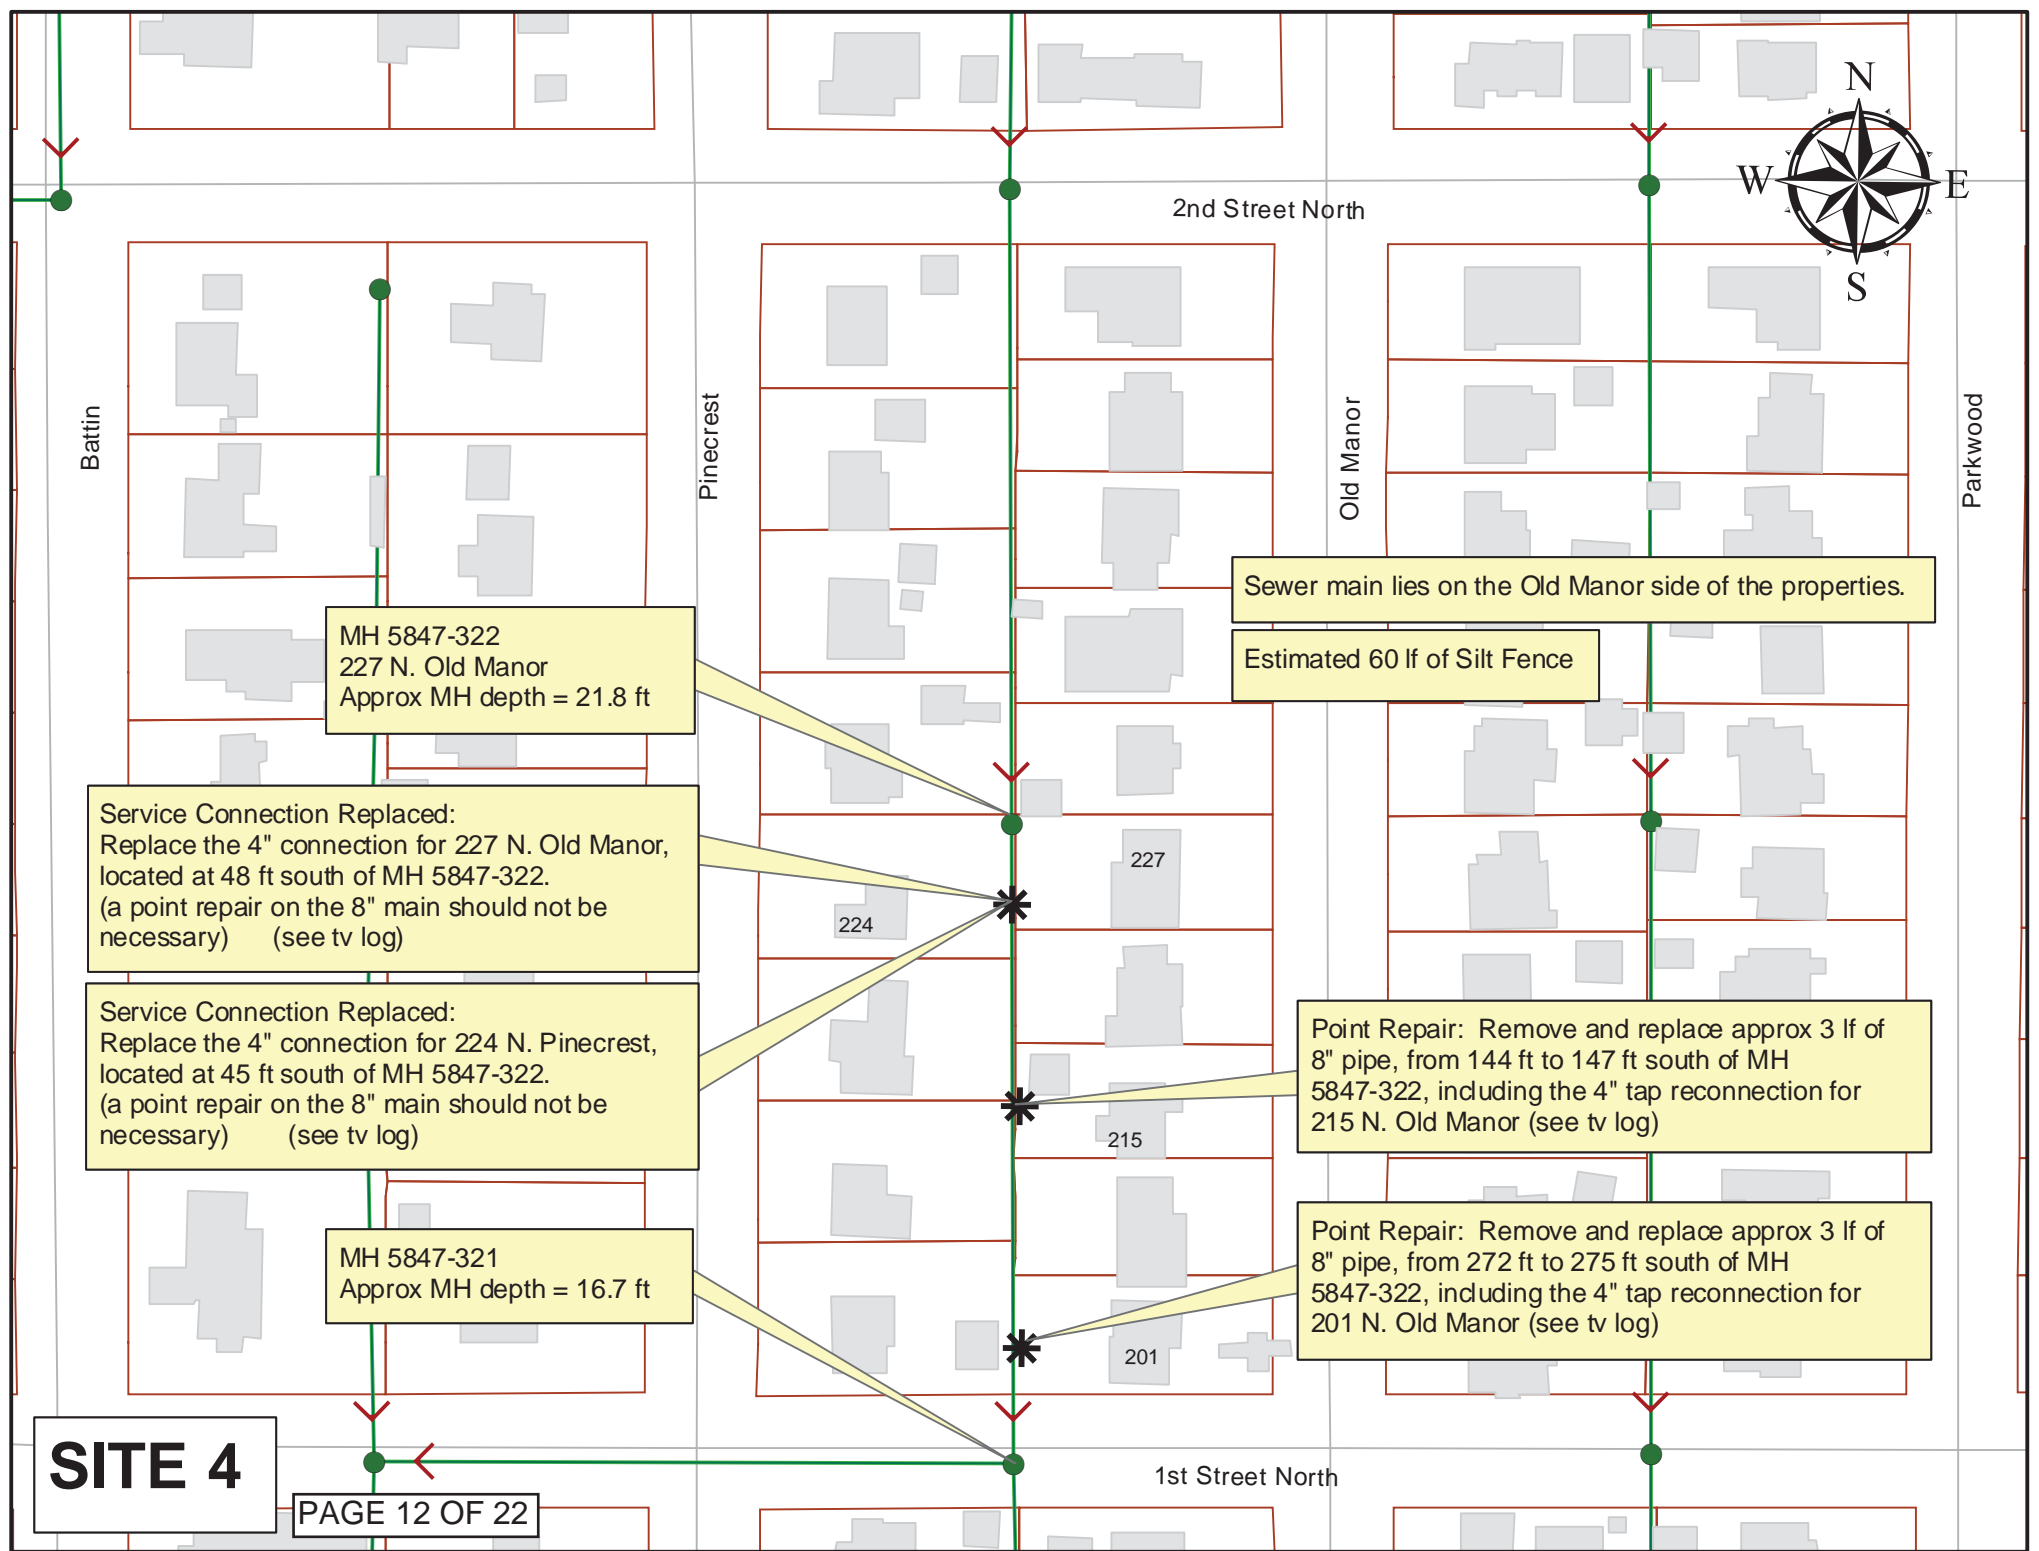
MH 5847-322  
227 N. Old Manor  
Approx MH depth = 21.8 ft

Sewer main lies on the Old Manor side of the properties.

Service Connection Replaced:  
Replace the 4" connection for 227 N. Old Manor,  
located at 48 ft south of MH 5847-322.  
(a point repair on the 8" main should not be  
necessary) (see tv log)

Service Connection Replaced:  
Replace the 4" connection for 224 N. Pinecrest,  
located at 45 ft south of MH 5847-322.  
(a point repair on the 8" main should not be  
necessary) (see tv log)

Point Repair: Remove and replace approx 3 lf of  
8" pipe, from 144 ft to 147 ft south of MH  
5847-322, including the 4" tap reconnection for  
215 N. Old Manor (see tv log)

MH 5847-321  
Approx MH depth = 16.7 ft

Point Repair: Remove and replace approx 3 lf of  
8" pipe, from 272 ft to 275 ft south of MH  
5847-322, including the 4" tap reconnection for  
201 N. Old Manor (see tv log)

Estimated 60 lf of Silt Fence
