Install 661 lf of 8"
Cured-in-Place Liner

Install 337 lf of 8"
Cured-in-Place Liner

SITE 4

Television Inspection Master Report

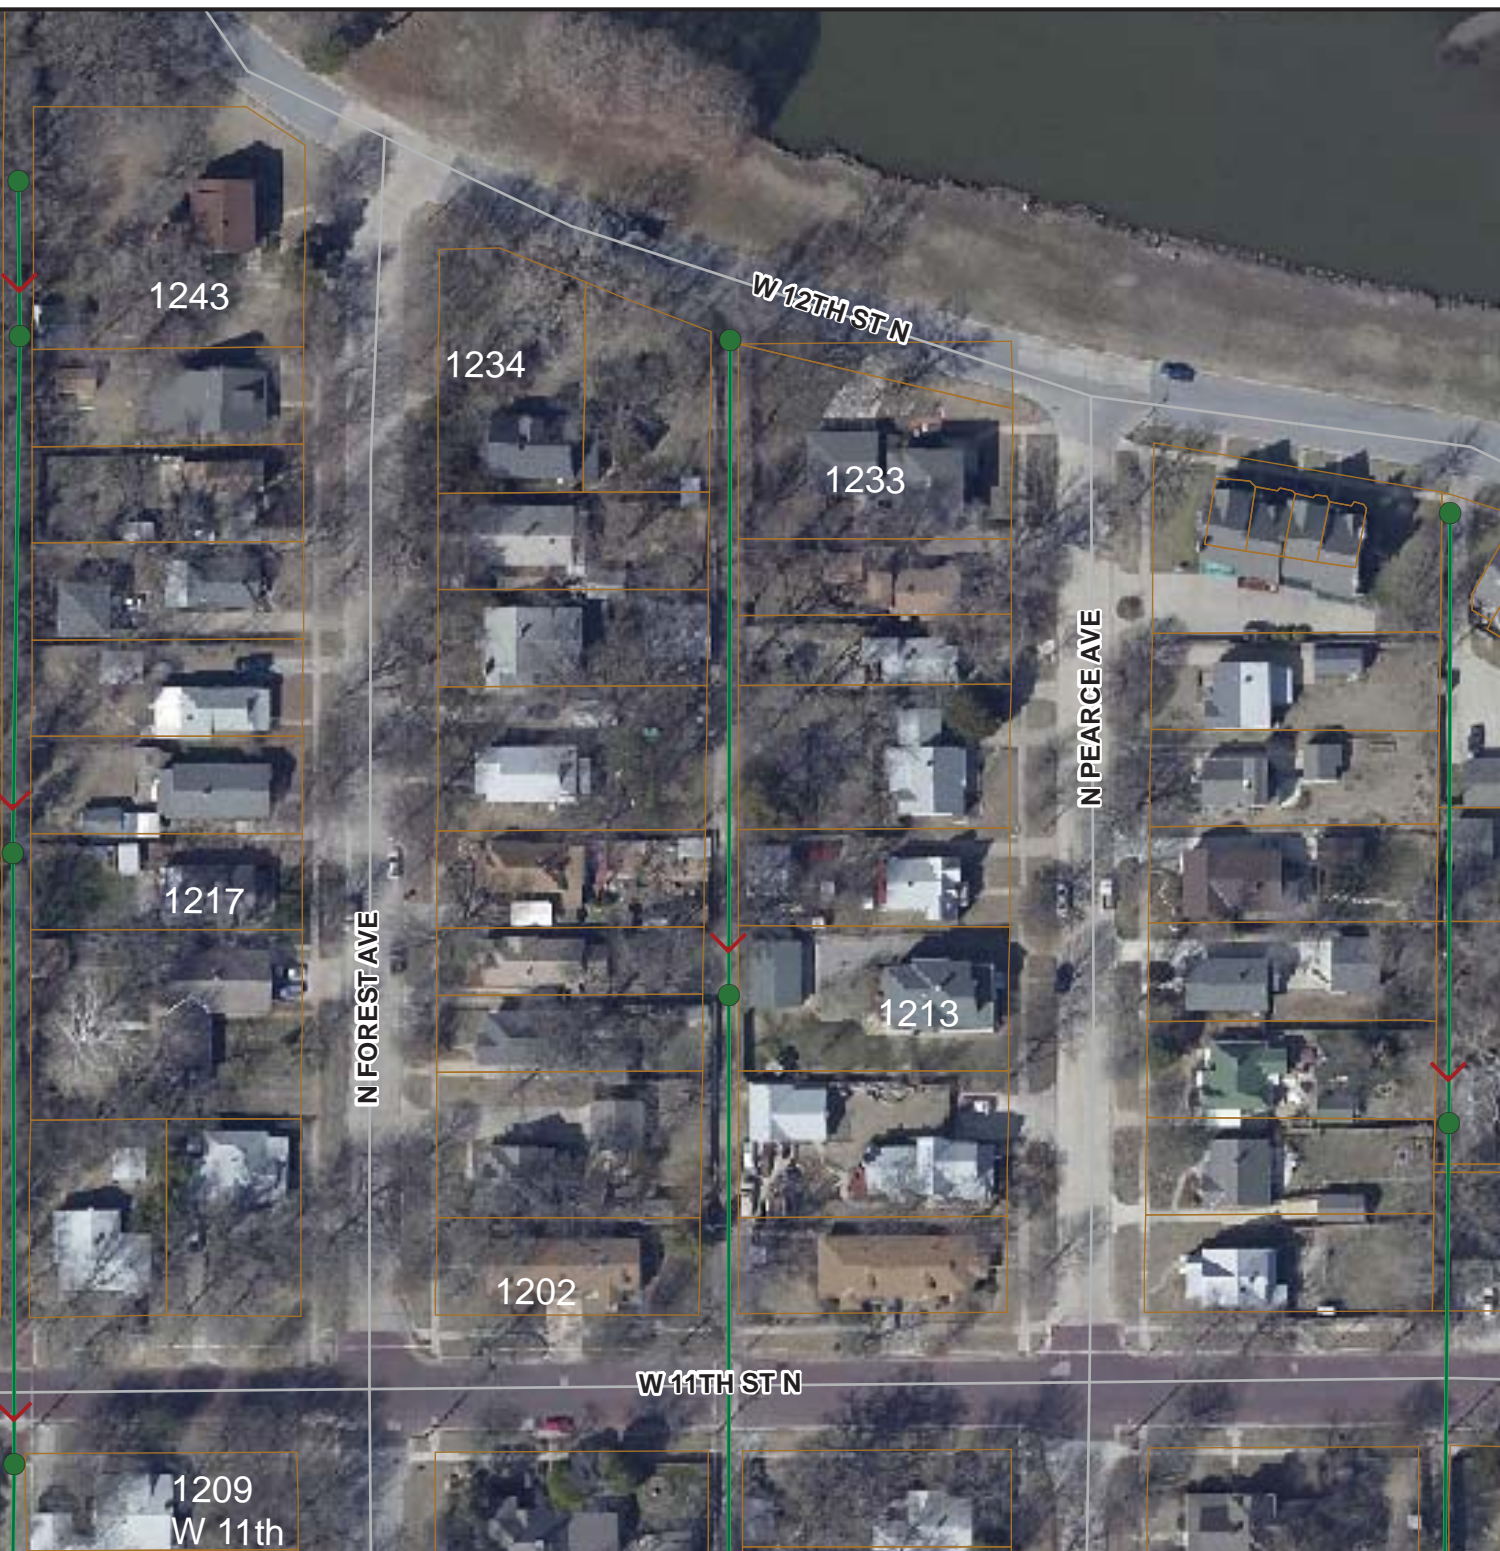
MH 5448-530
Depth not measured

MH 5448-520
Approx. MH depth = 5.1 ft

MH 5448-518
Approx. MH depth = 5.3 ft

MH 5448-515
Approx. MH depth = 4.4 ft

MH 5448-532
Approx. MH depth = 8.2 ft

MH 5448-529
Approx. MH depth = 6.3 ft
