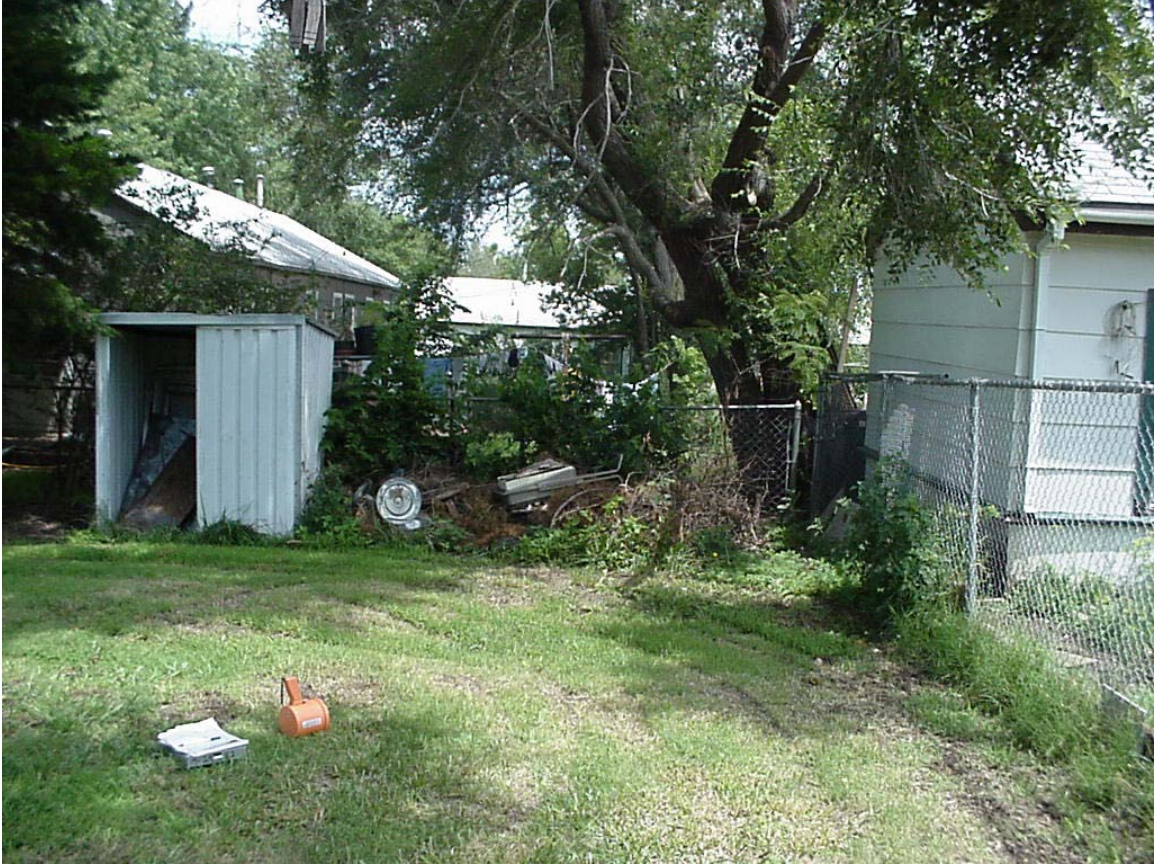
Standing west of Cleanout 5744-711CO, looking north. There is a garage and trees which may (or may not) be over the sewer line. Contractor has the option of relocating the line if Pipe Reaming or Pipe Bursting is not used. There is no record of where the connections are located. No televising could be done between 5744-712CO and 5744-711CO.

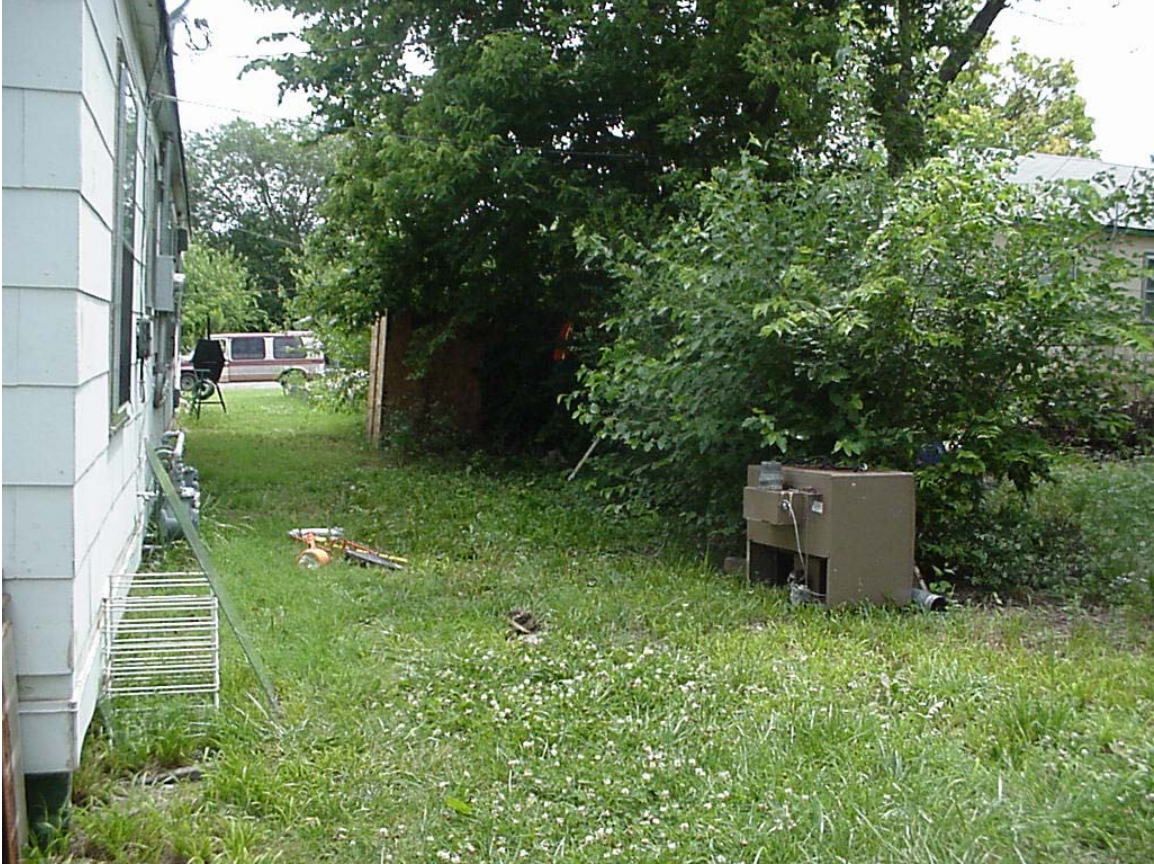
Standing west of Cleanout 5744-713CO, looking east.

Cleanout 5744-713CO is next to the fence at the south property line, under the trees.
Cleanout 5744-714CO is by the house, under a piece of concrete.
We did not find 5744-712CO.

If Contractor chooses to relocate the line between 5744-712 and 5744-711, he may also move the location of 5744-712 to accommodate. Service lines to this building shall be moved accordingly.
