CITY OF WICHITA  
 PLAN  
 STA. 122+30 TO STA. 128+60

DESIGNED	ABS	DRAWN	AL/ES	SCALE	SHEET NO.
CHECKED	ABS/CDM	DATE	07/14	1"=20'	9

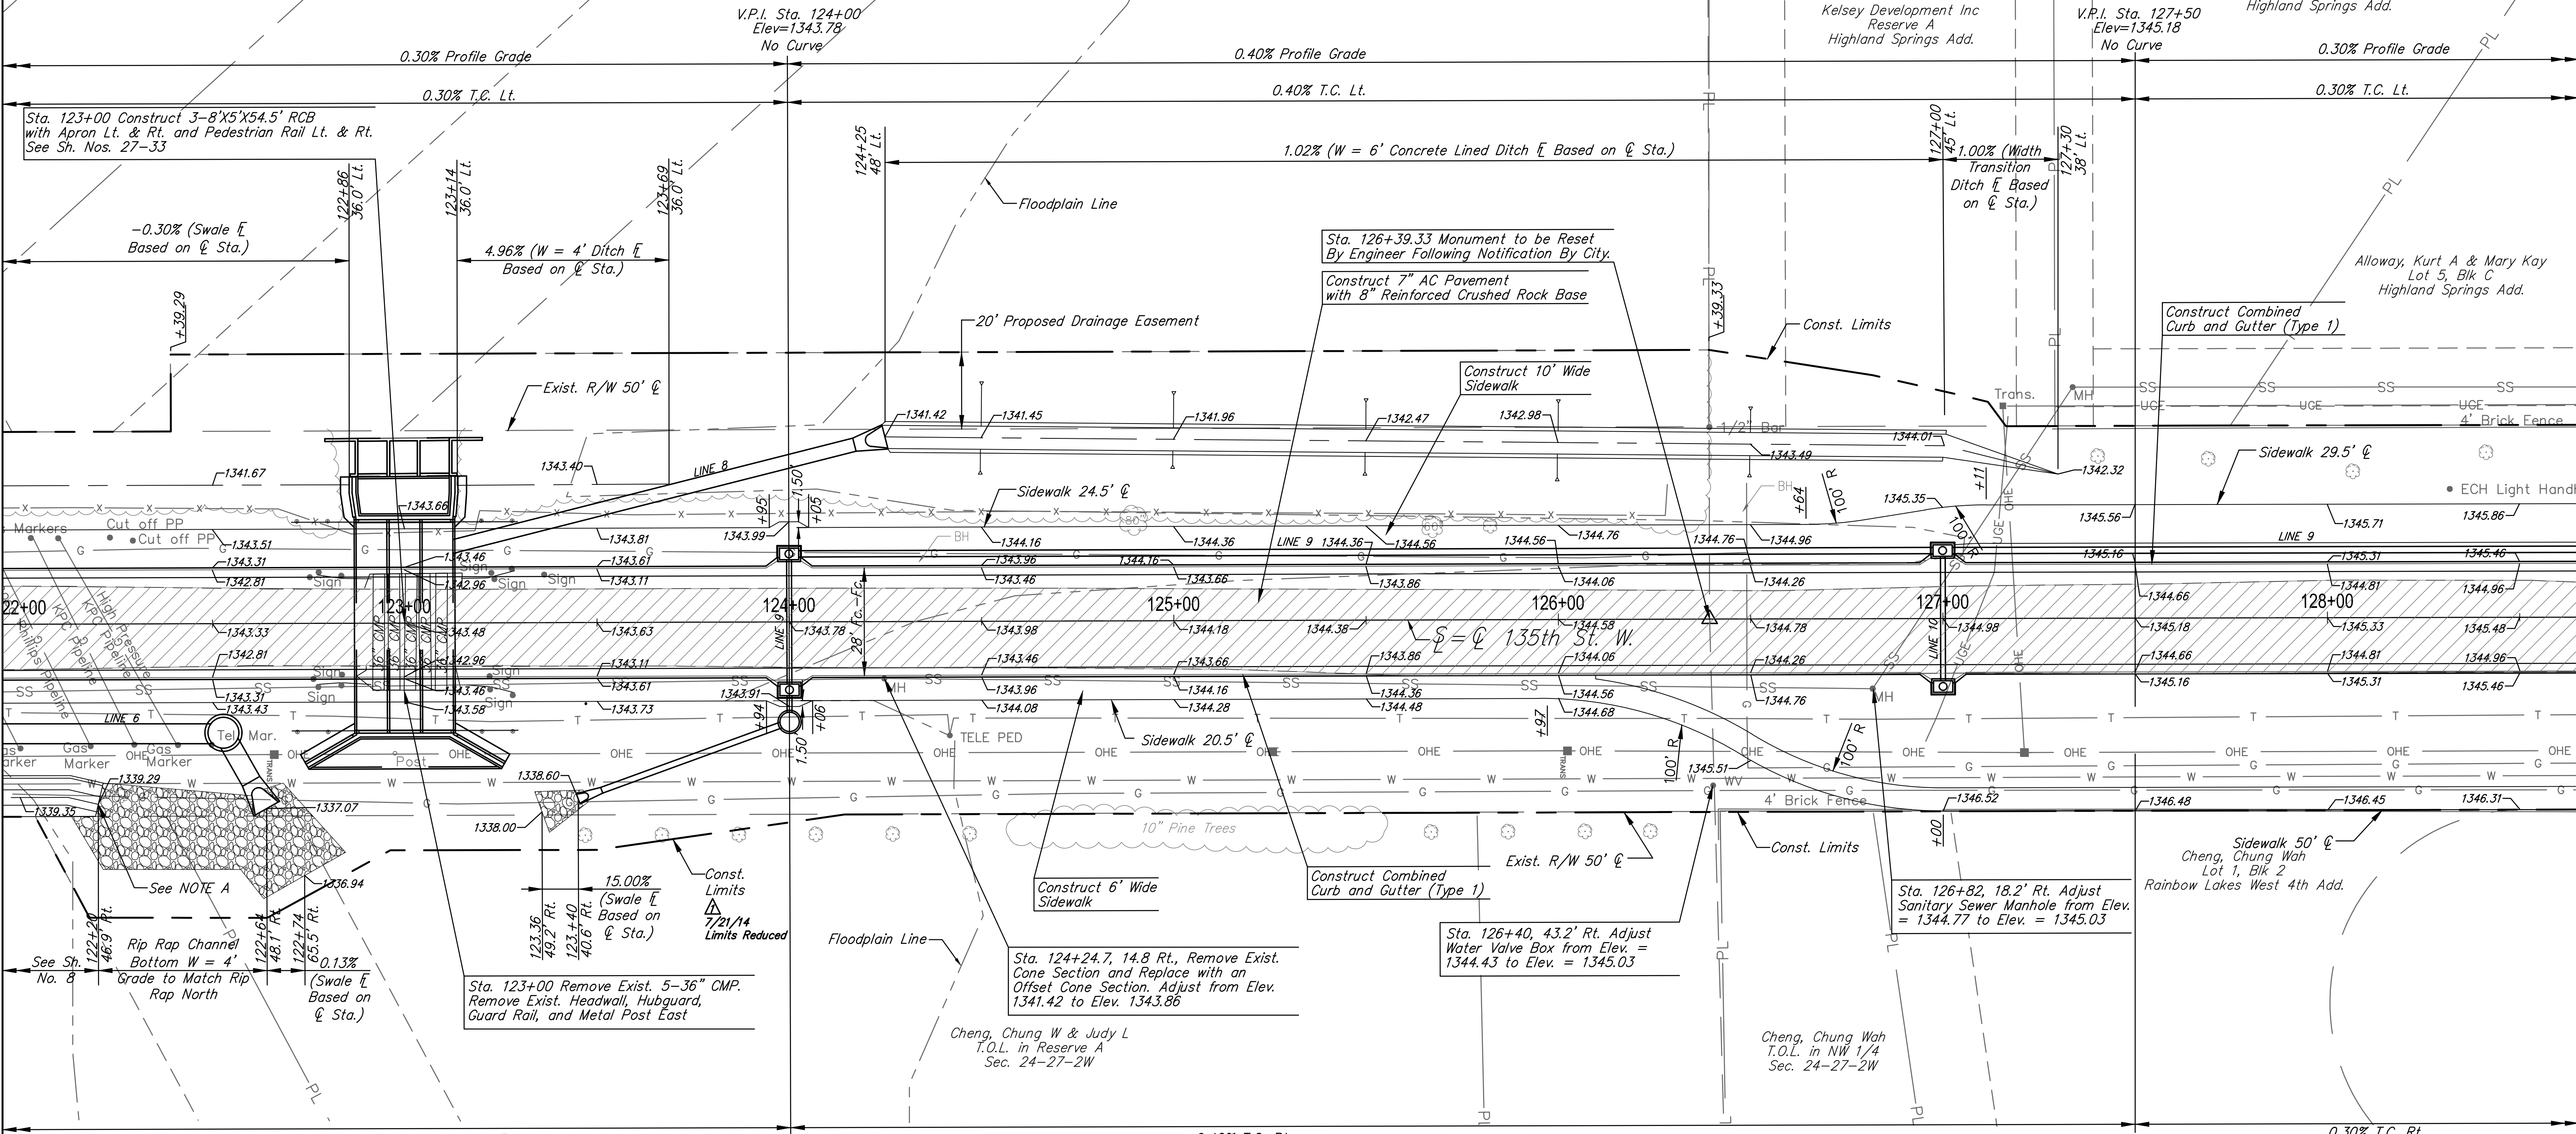
Tree removal Sta. 113+20 Lt. to 126+40 Lt. shall be paid for as "Site Clearing".

W 1/4 Cor., Sec. 24, T27S, R2W = P.O.T. Sta. 126+39.33 @ 135th Street  
 1. Found 1" Iron Pipe  
 2. 60D nail in hedge tree  
 3. Three Nails in highline pole  
 4. Southwest corner of concrete wall  
 23.21' W.  
 62.84' N.N.E.  
 49.65' N.E.

NOTE A  
 Sta. 122+20, 46.9' Rt. Construct Toe Wall at End of Flume, See Detail This Sheet

CAUTION:  
 Multiple Gas Line Crossings - See General Notes, Sh. No. 2

Center, Sec. 24, T27S, R2W  
 1. Found 1" iron pipe  
 2. 60D nail and washer in 40" hedge tree  
 3. Nail and shiner in West face of 15" hedge tree  
 4. 60D nail and washer in South face of hedge tree  
 8.91' W.  
 9.49' N.  
 10.51' E.

Center, Sec. 23, T27S, R2W  
 1. Found 8" x 8" Limestone, Found 1/2" rebar with ID cap "TILSI CLS 22" on outside of stone  
 2. 60D nail in 30" split hedge tree  
 3. PK Nail in South face of 30" hedge tree  
 4. 60D Nail and washer in North face of 30" split hedge tree  
 14.80' W.  
 5.50' N.  
 32.80' E.
