POINT REPAIR:

Replace service connection for 8321 E. Peachtree located 104 ft east of MH 6047-180

Replace service connection for 8302 E. Kellogg located 106 ft east of MH 6047-180, including approx. 4 lf of service line from the tap to the building.

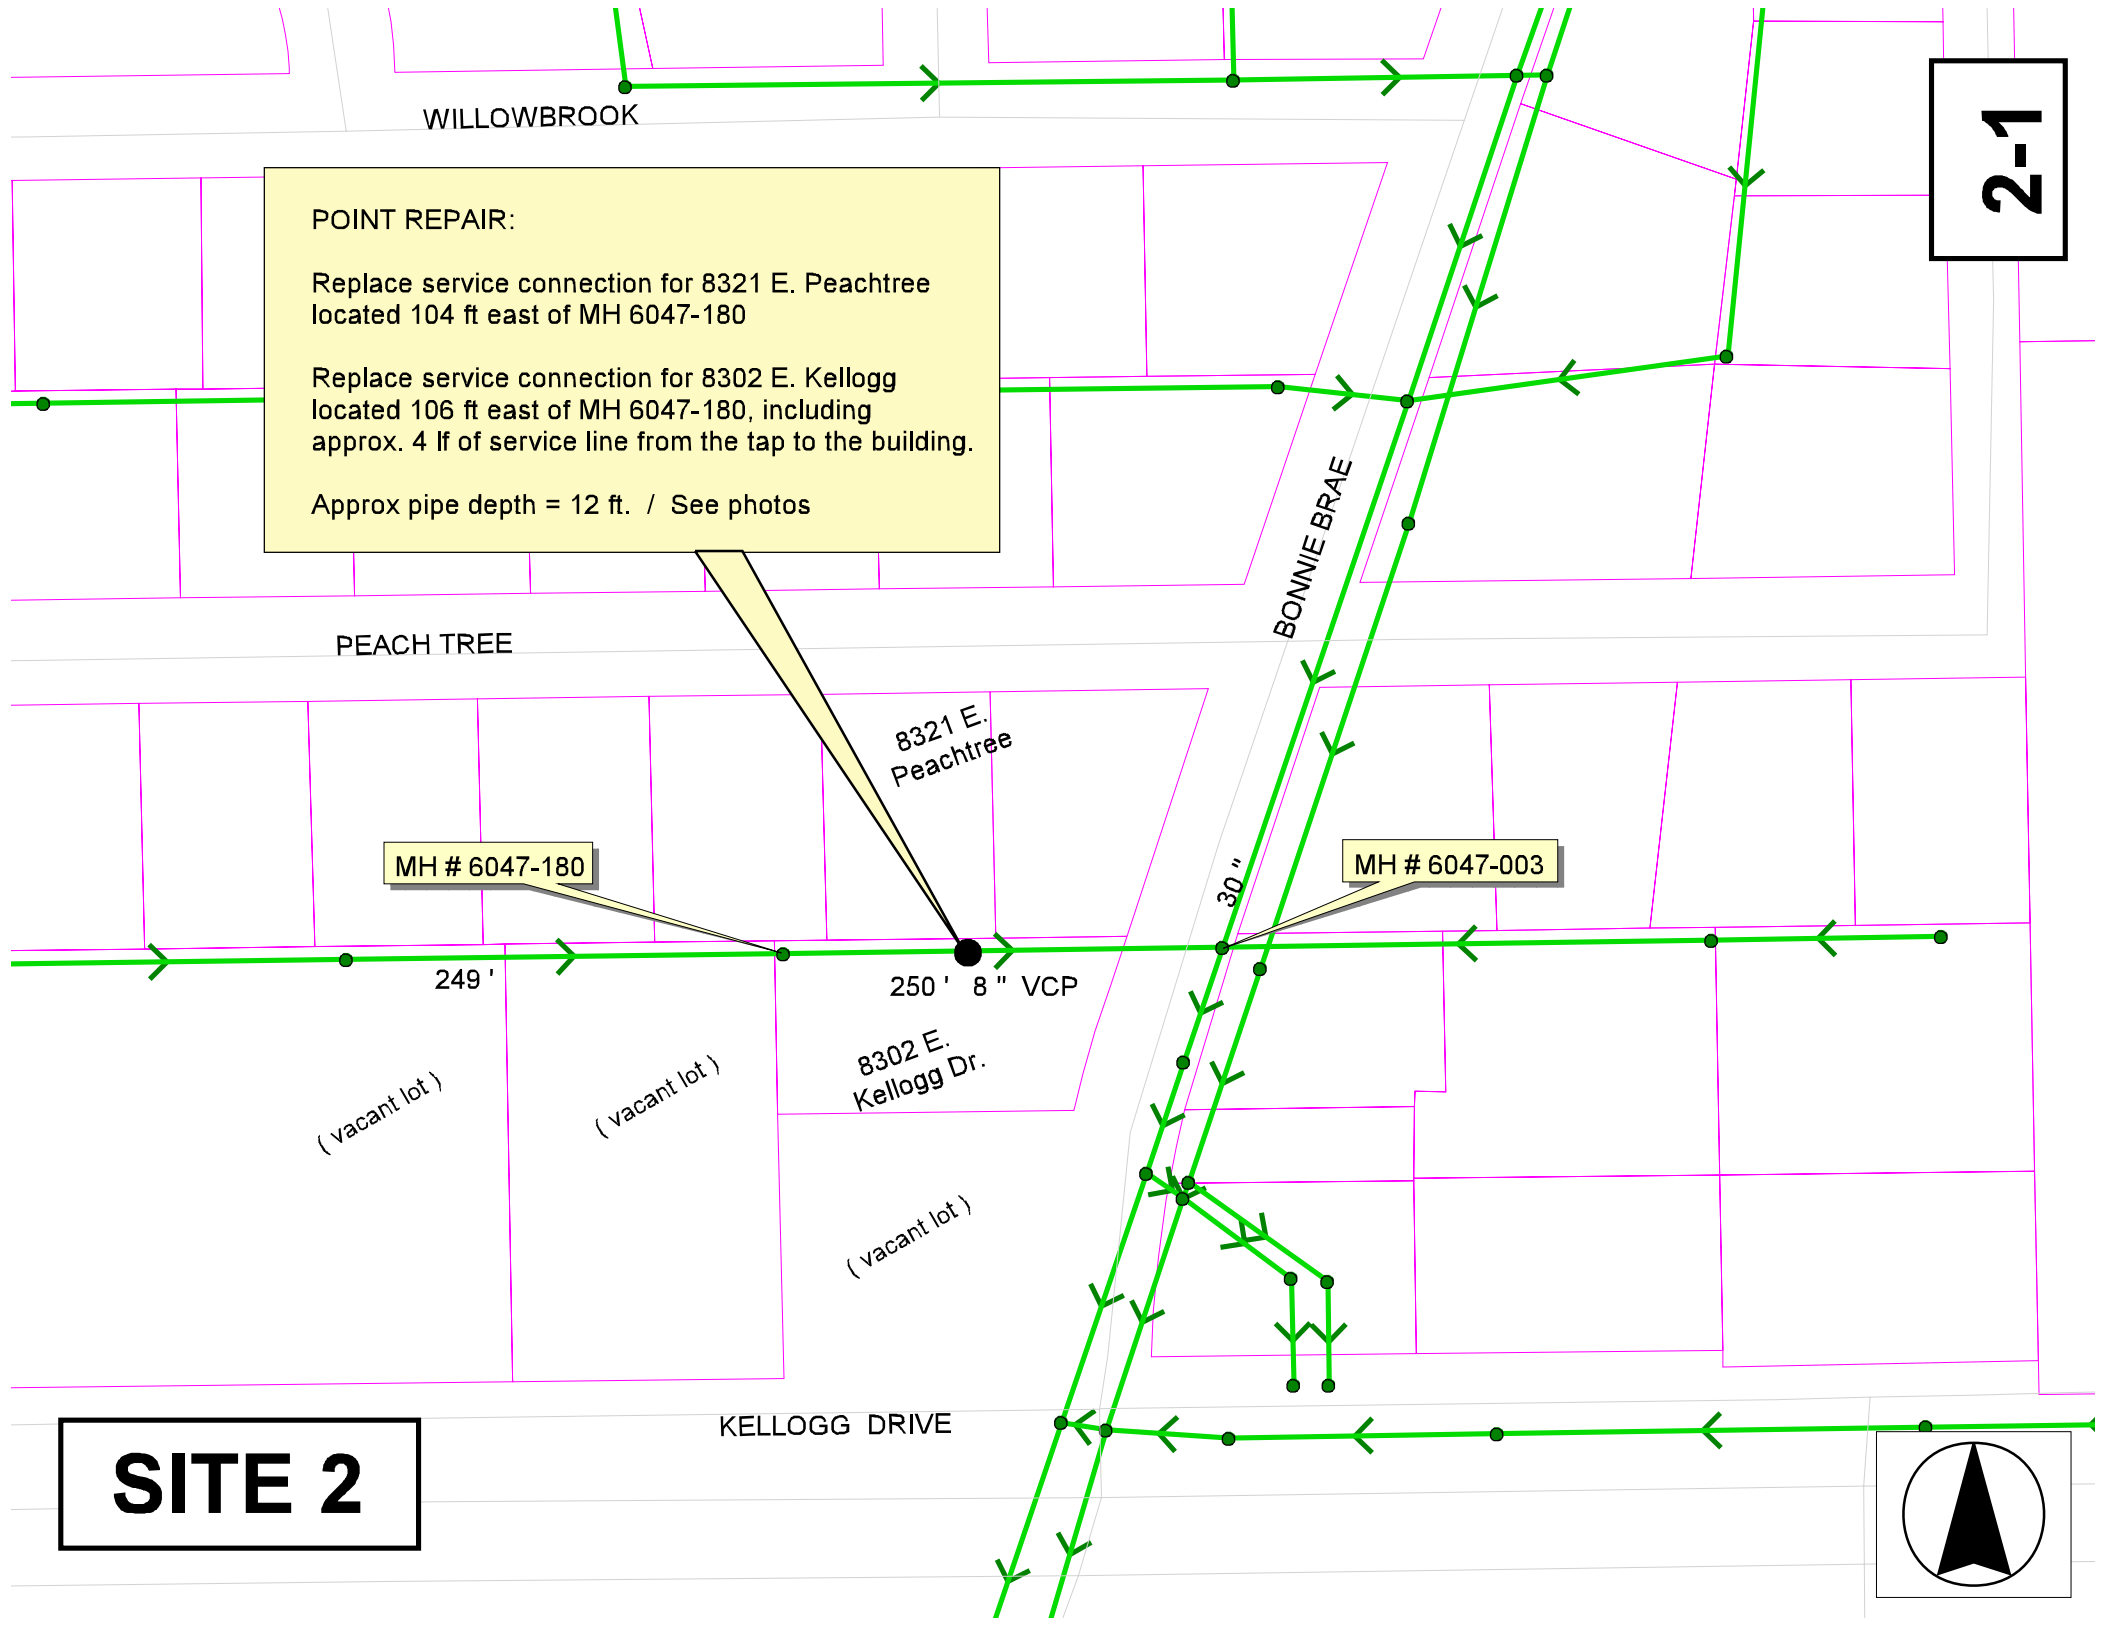
SITE 2

PEACH TREE

8321 E. Peachtree

MH # 6047-180

MH # 6047-003

250' 8" VCP

8302 E. Kellogg Dr.

Approx pipe depth = 12 ft. / See photos

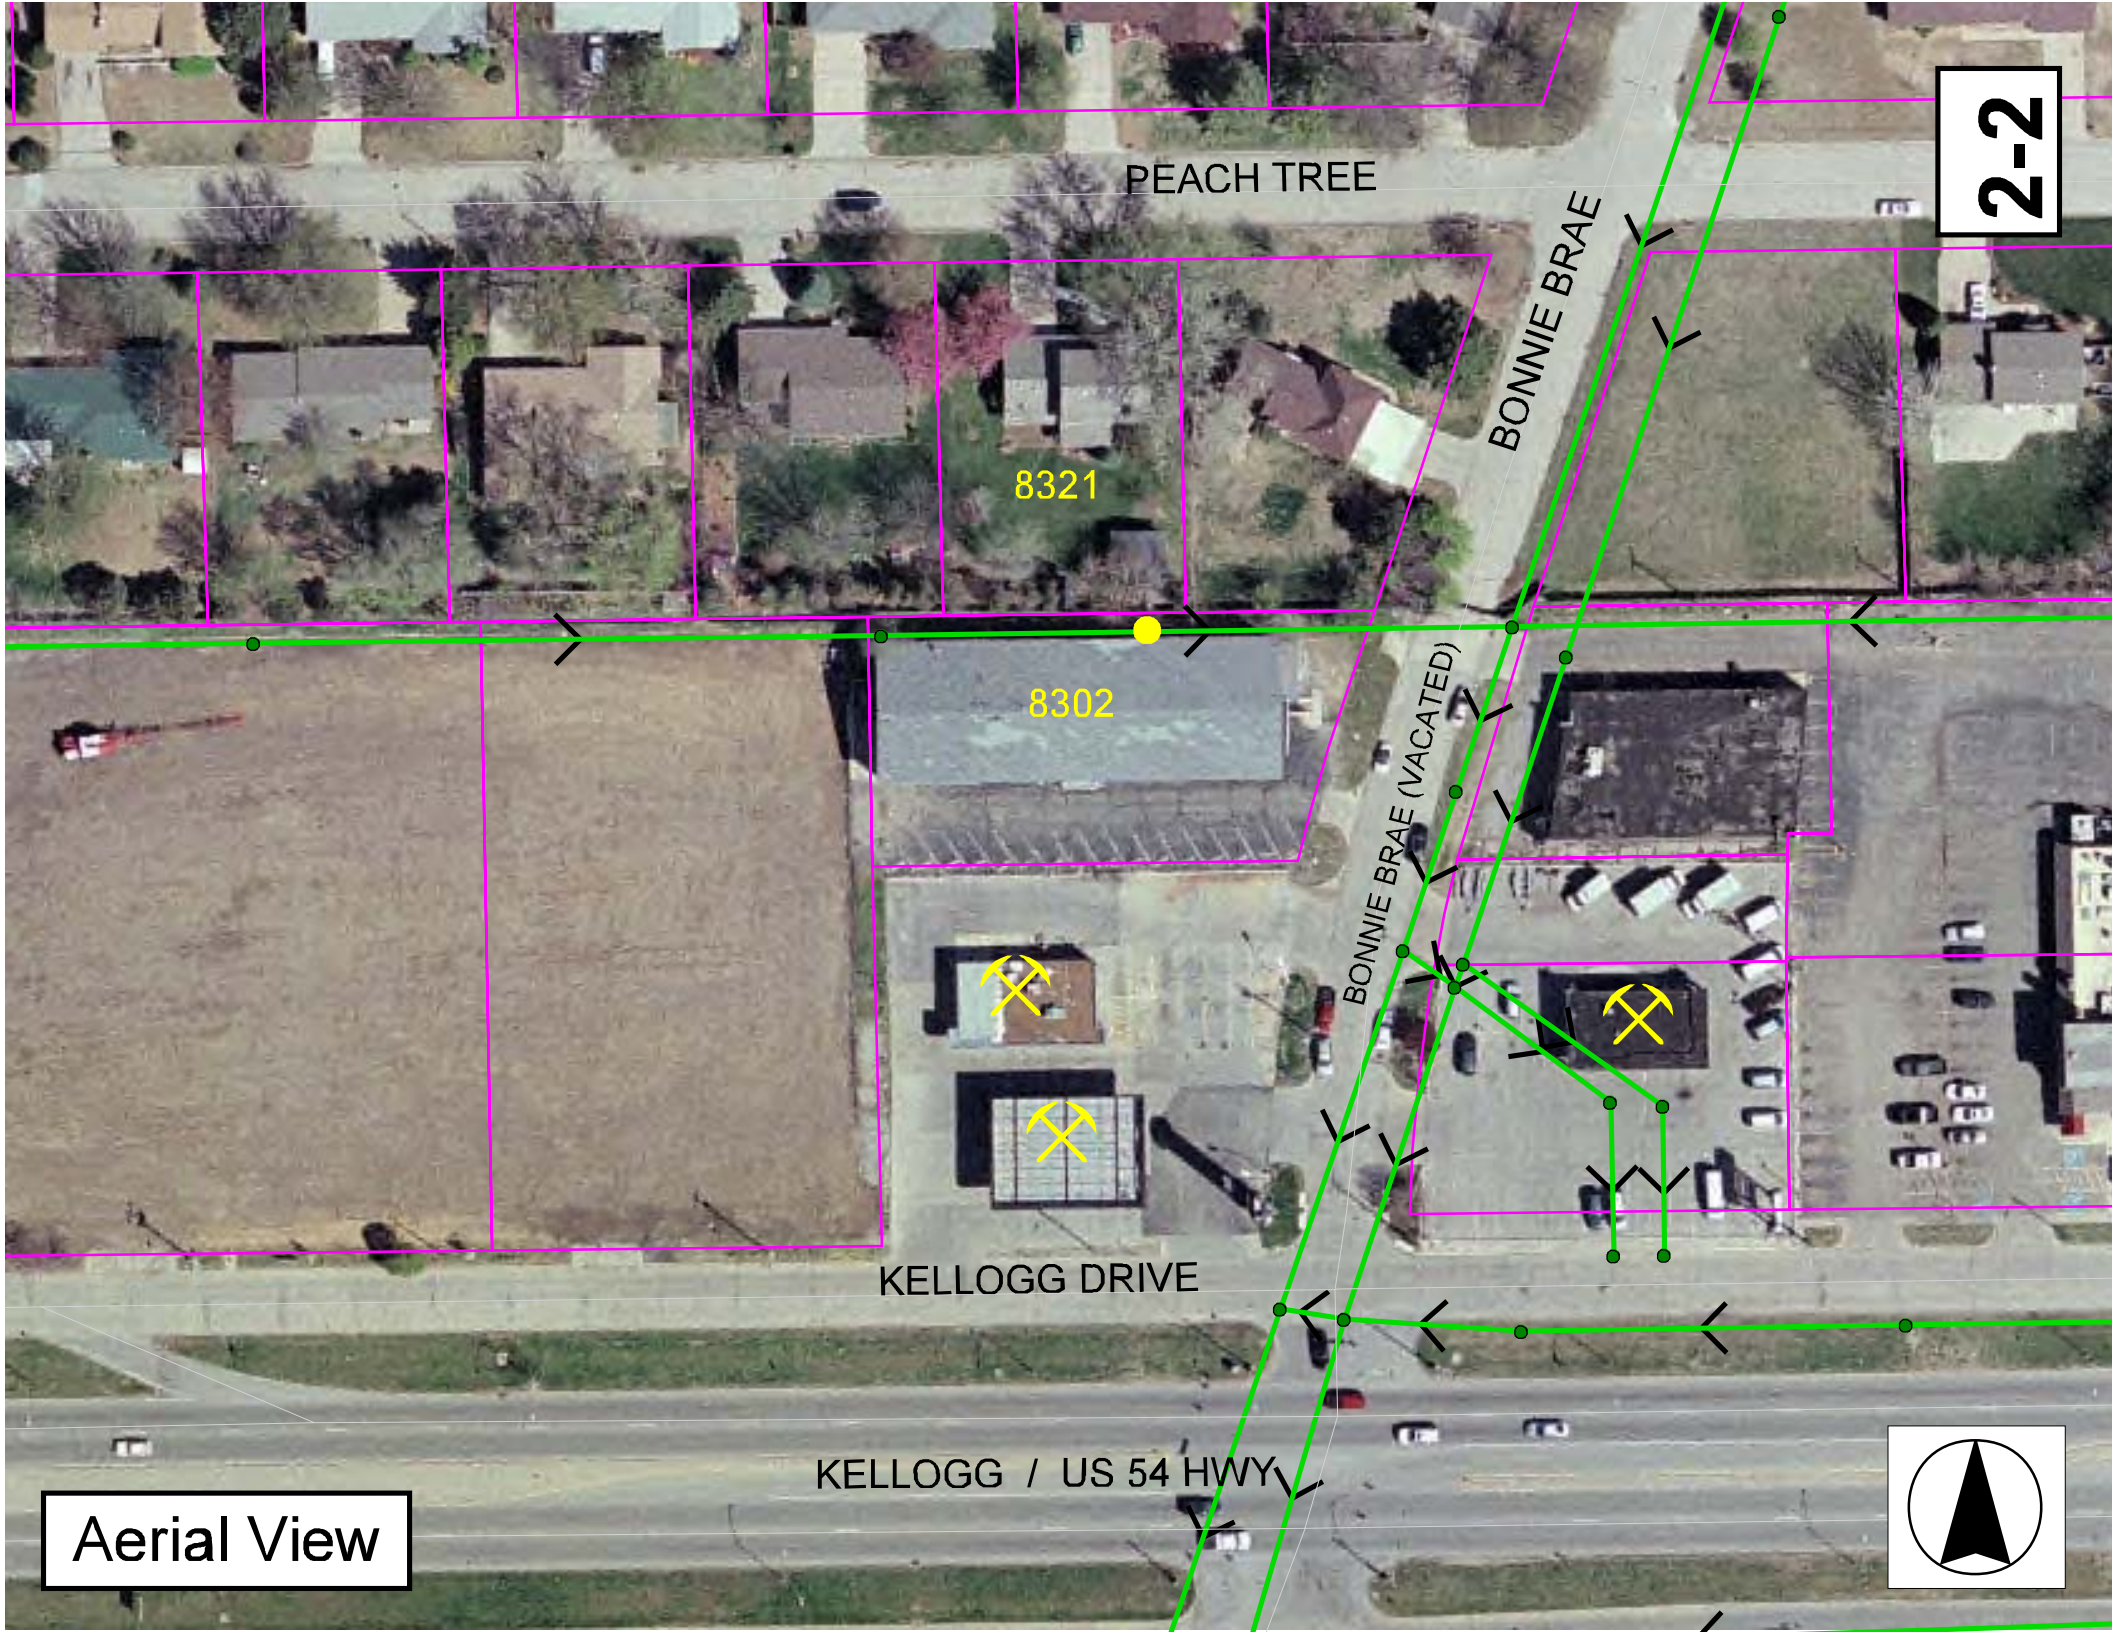
Aerial View

PEACH TREE

BONNIE BRAE (VACATED)

KELLOGG / US 54 HWY

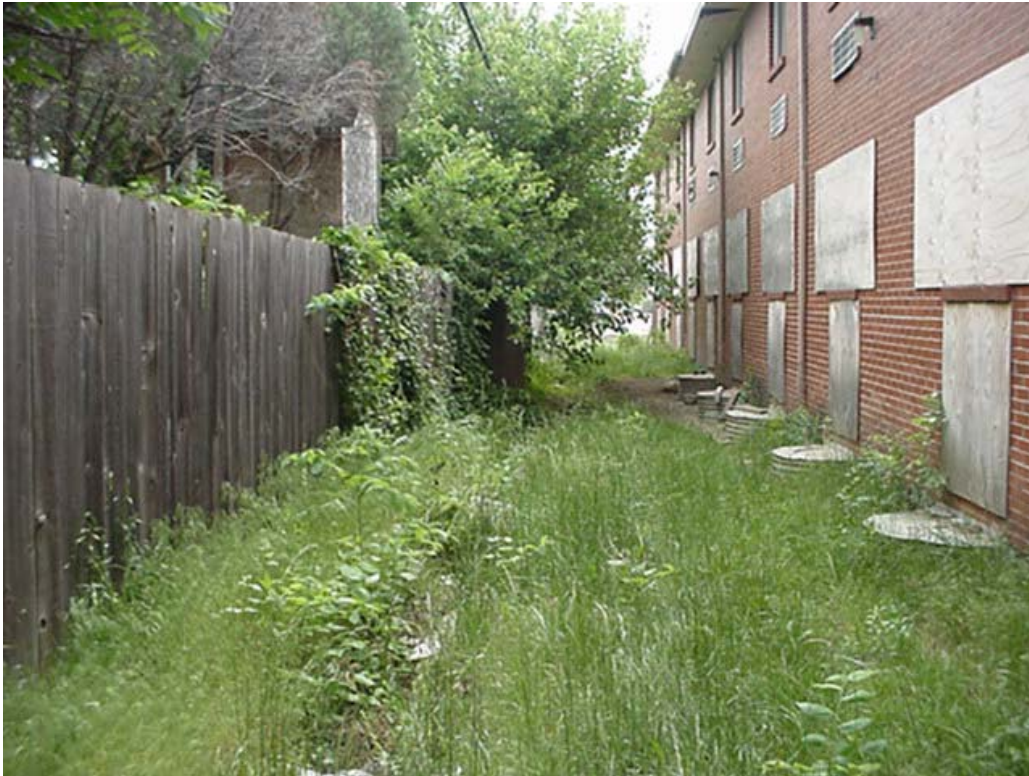
Standing west of the point repair area, facing east
There is approx. 10 ft. to 12 ft of width between the building and the fence.
The wood fence is located on the Peachtree properties.

The easement is 16' wide, with 8' on either side of the properties.
The window wells of 8302 E. Kellogg appear to be at their 8' easement boundary.
8302 E. Kellogg is a vacant building at this time.

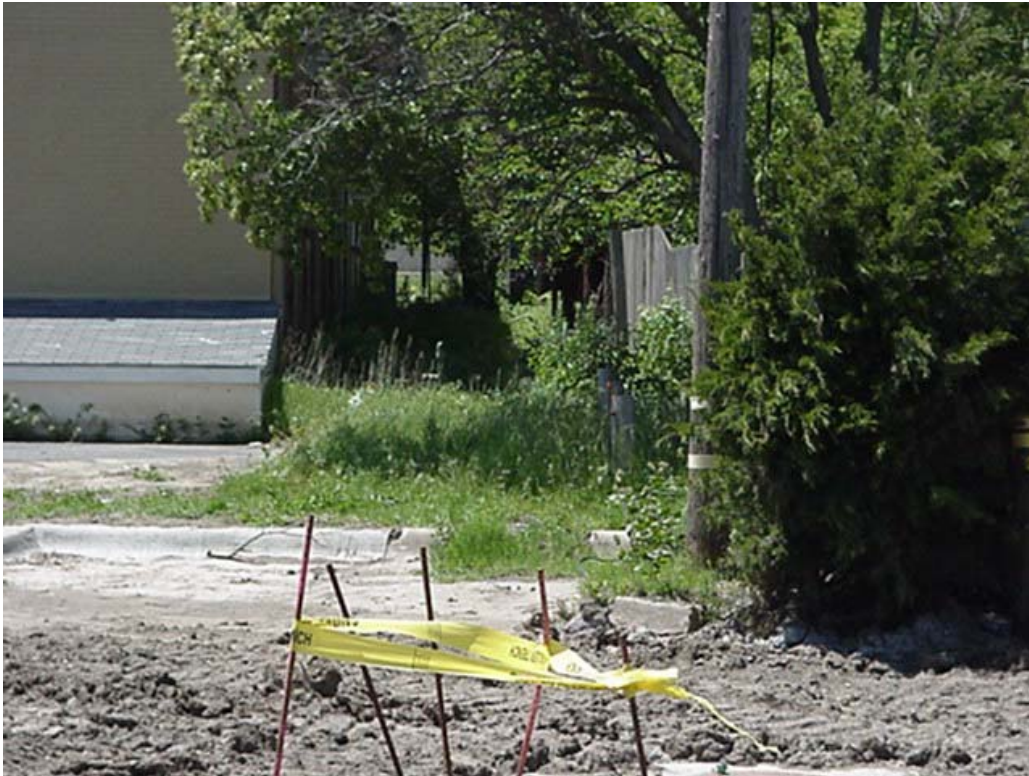
Standing in Bonnie Brae, looking west.
Bonnie Brae pavement has been removed at this point.
This will be the side that provides access for the point repair.

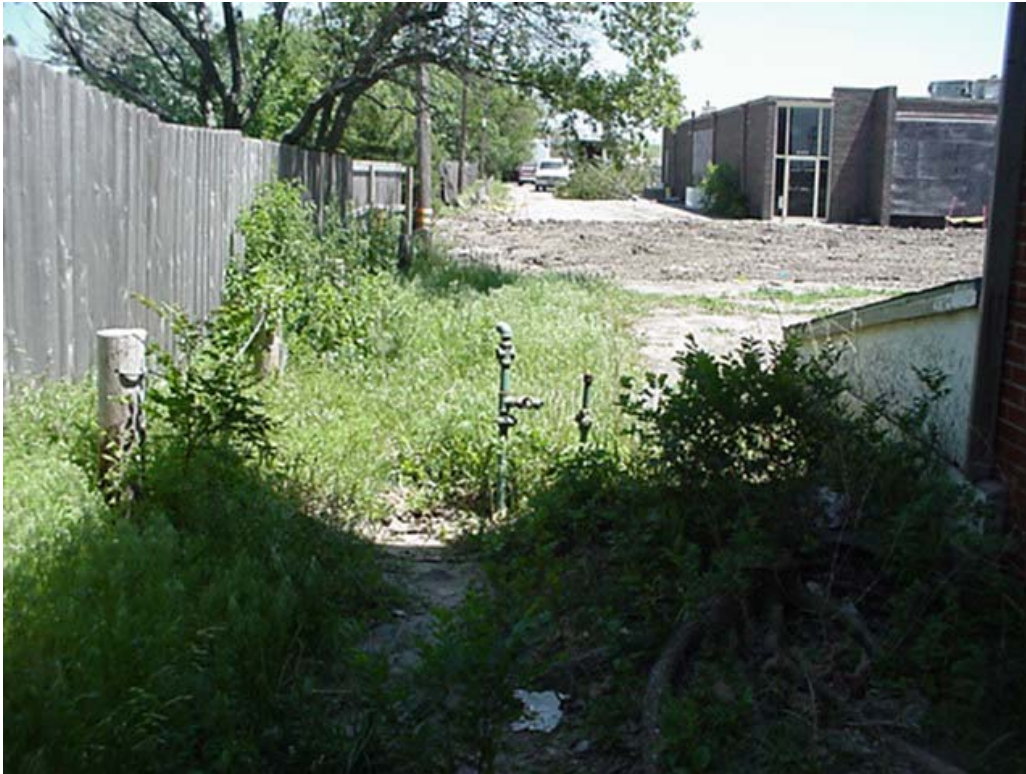
Standing at the east edge of 8302 E. Kellogg, looking east toward vacated Bonnie Brae. There are two vertical gas pipes that are blocking the entrance to the easement. Contractor is responsible to make the necessary arrangements for access to the easement.
