DOUGLAS AVE.
 STREETSCAPE
 IMPROVEMENTS
 WICHITA, KS

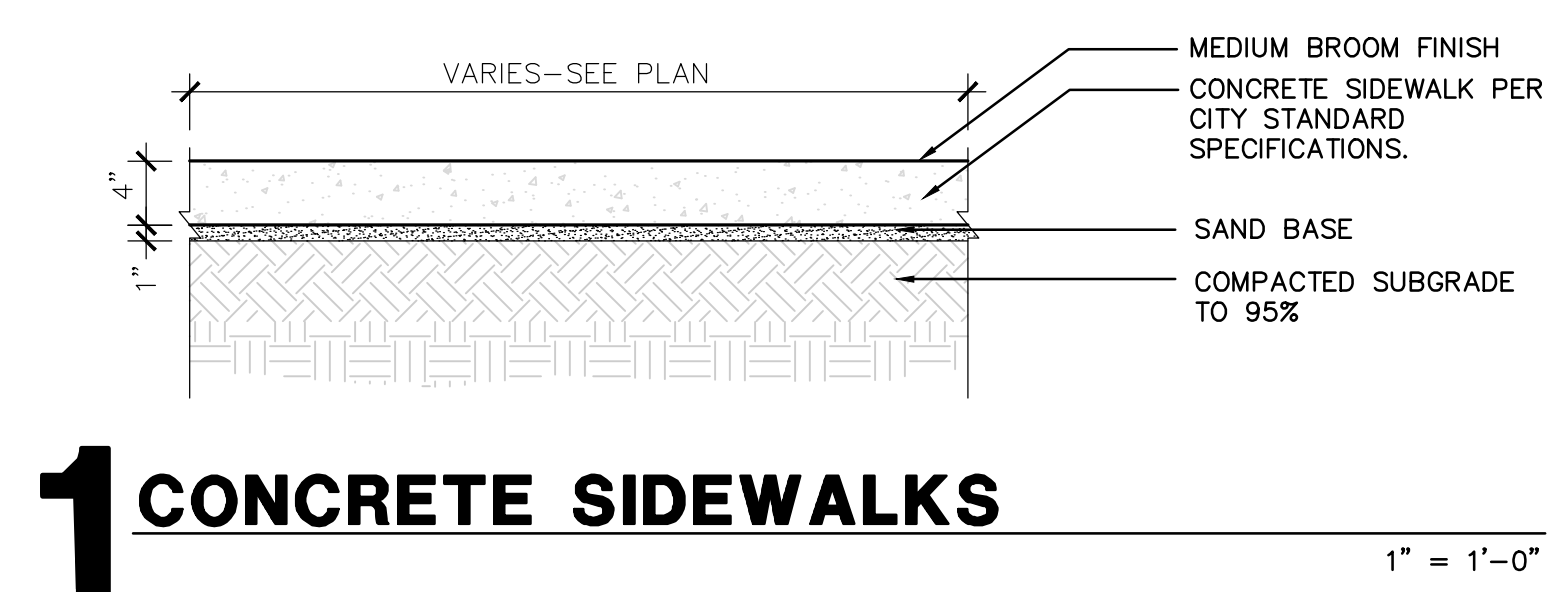
1 CONCRETE SIDEWALKS
 1" = 1'-0"

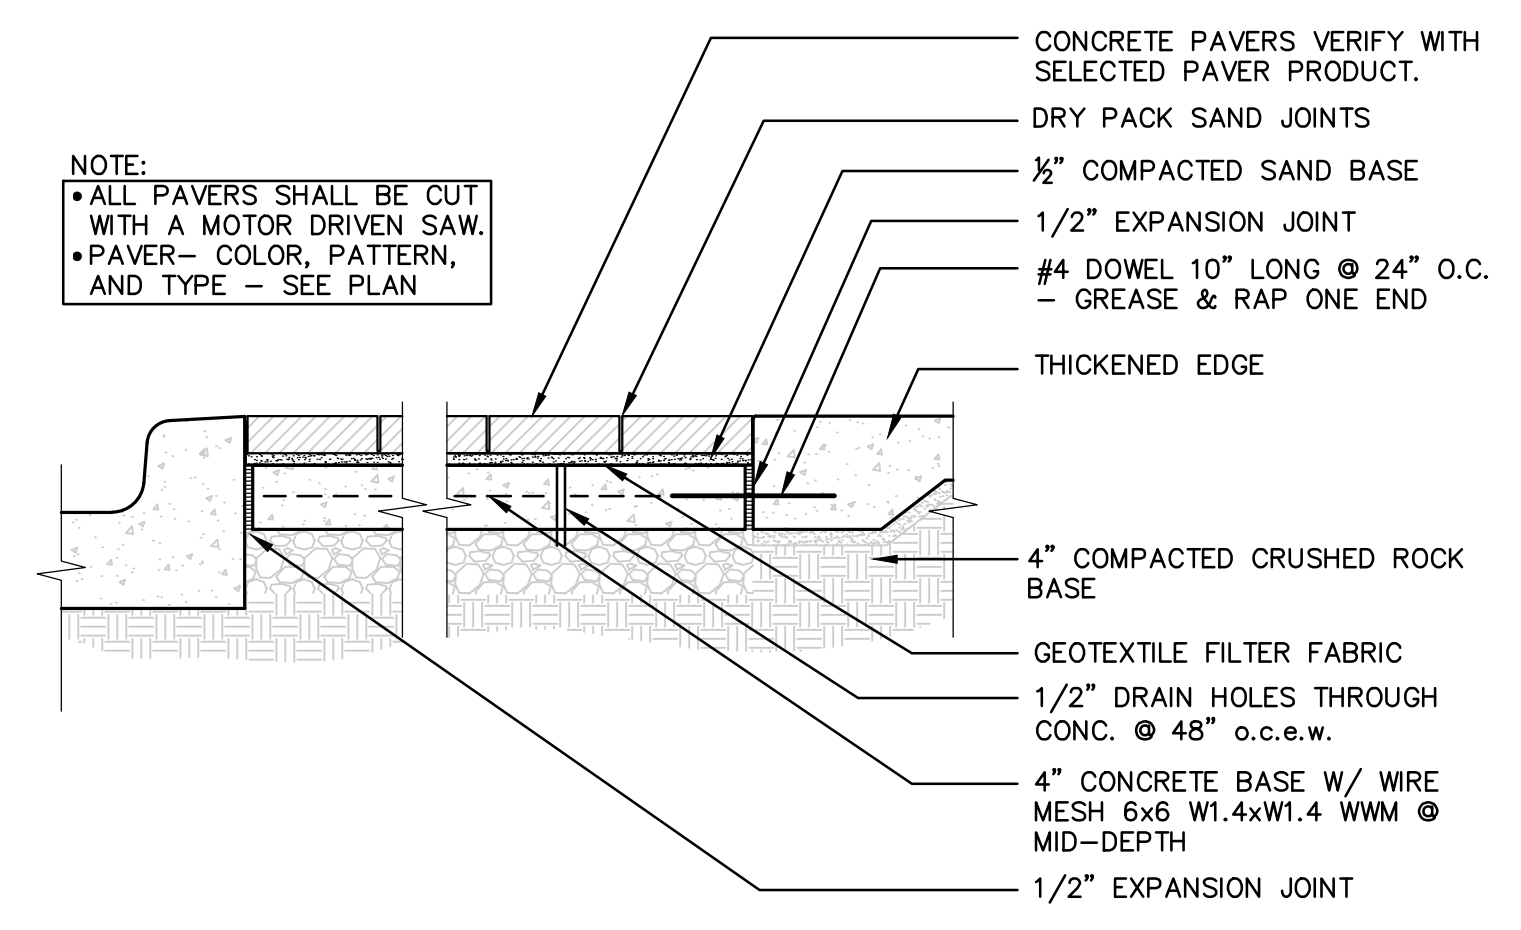
4 CONCRETE PAVER DETAIL
 CONCRETE BASE - TYPICAL INSTALLATION
 1" = 1'-0"

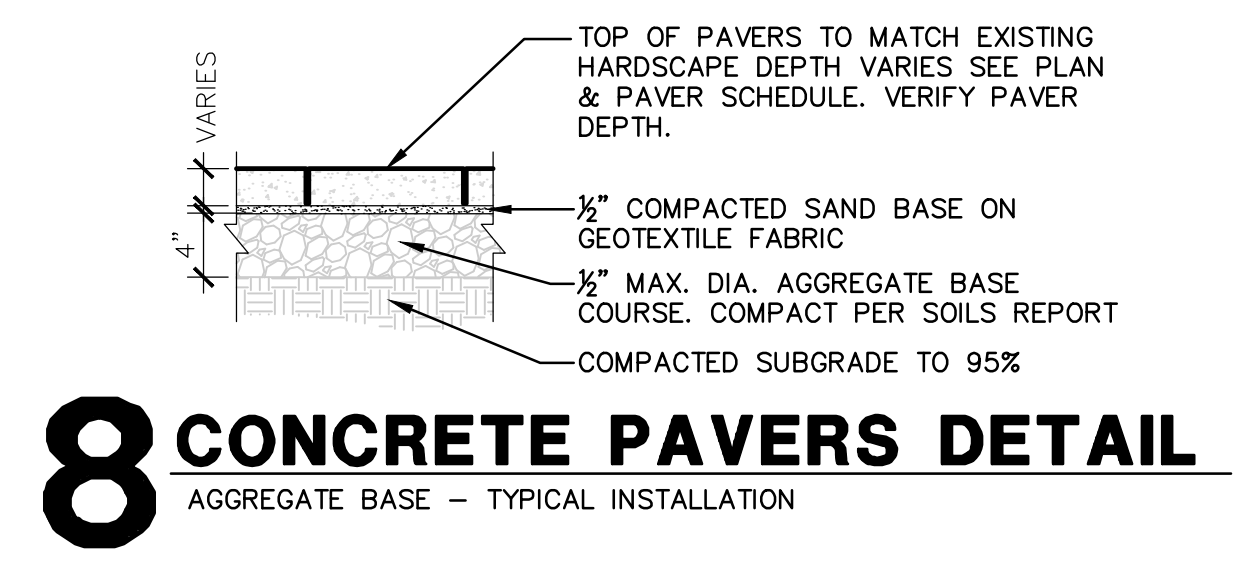
8 CONCRETE PAVERS DETAIL
 AGGREGATE BASE - TYPICAL INSTALLATION

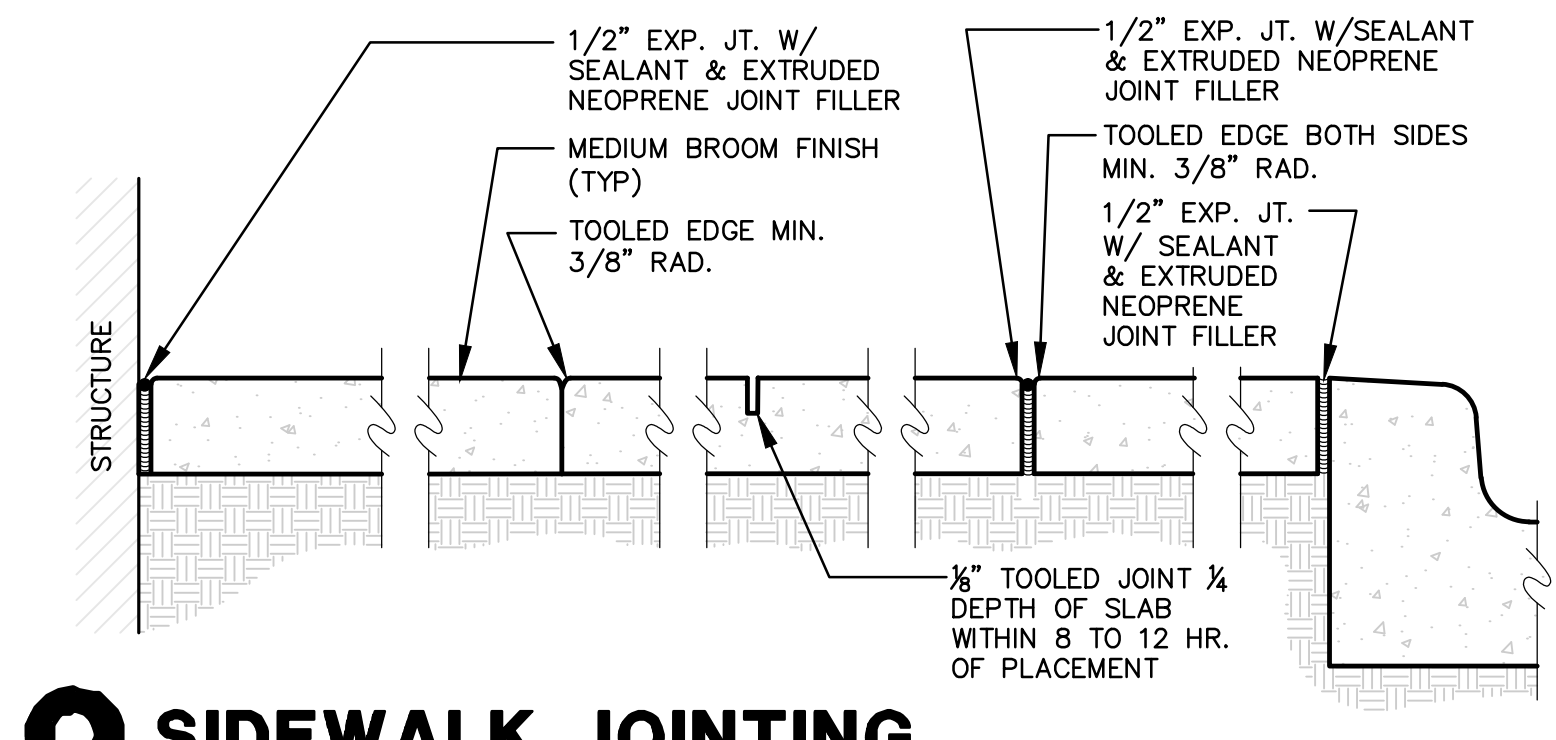
2 SIDEWALK JOINTING
 1 1/2" = 1'-0"

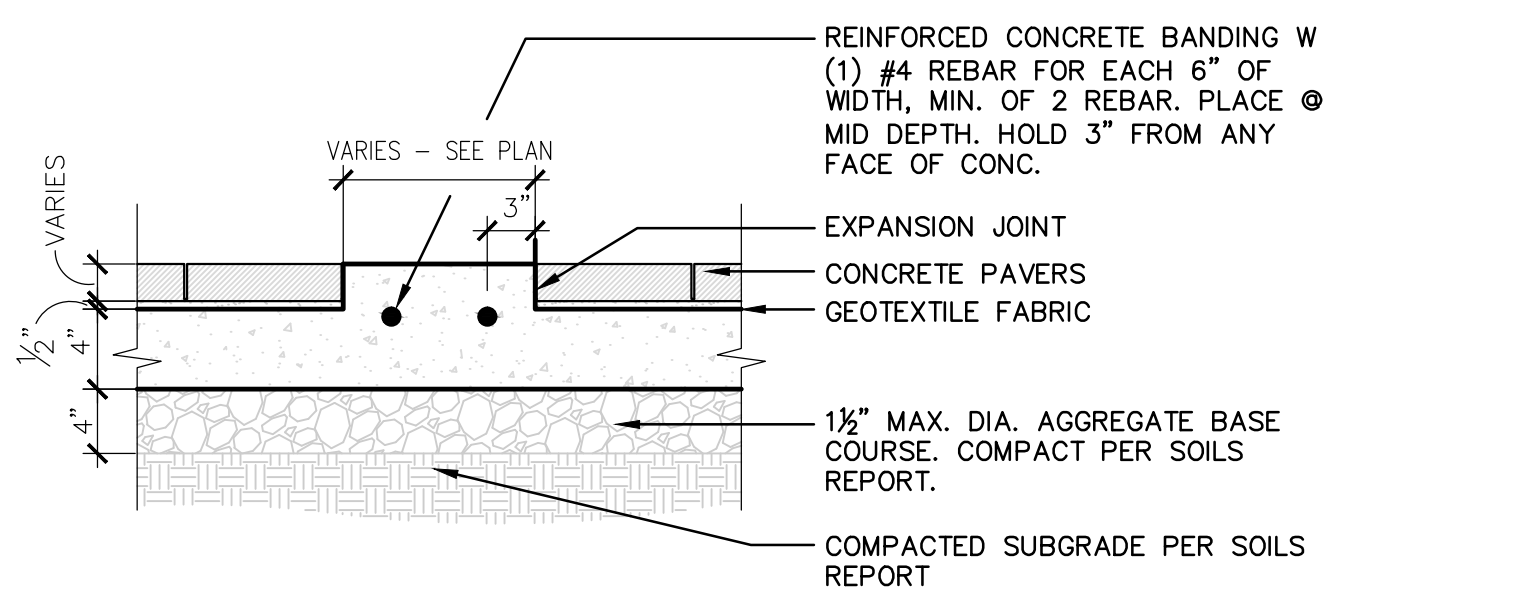
5 CONCRETE BAND IN PAVER FIELD
 1" = 1'-0"

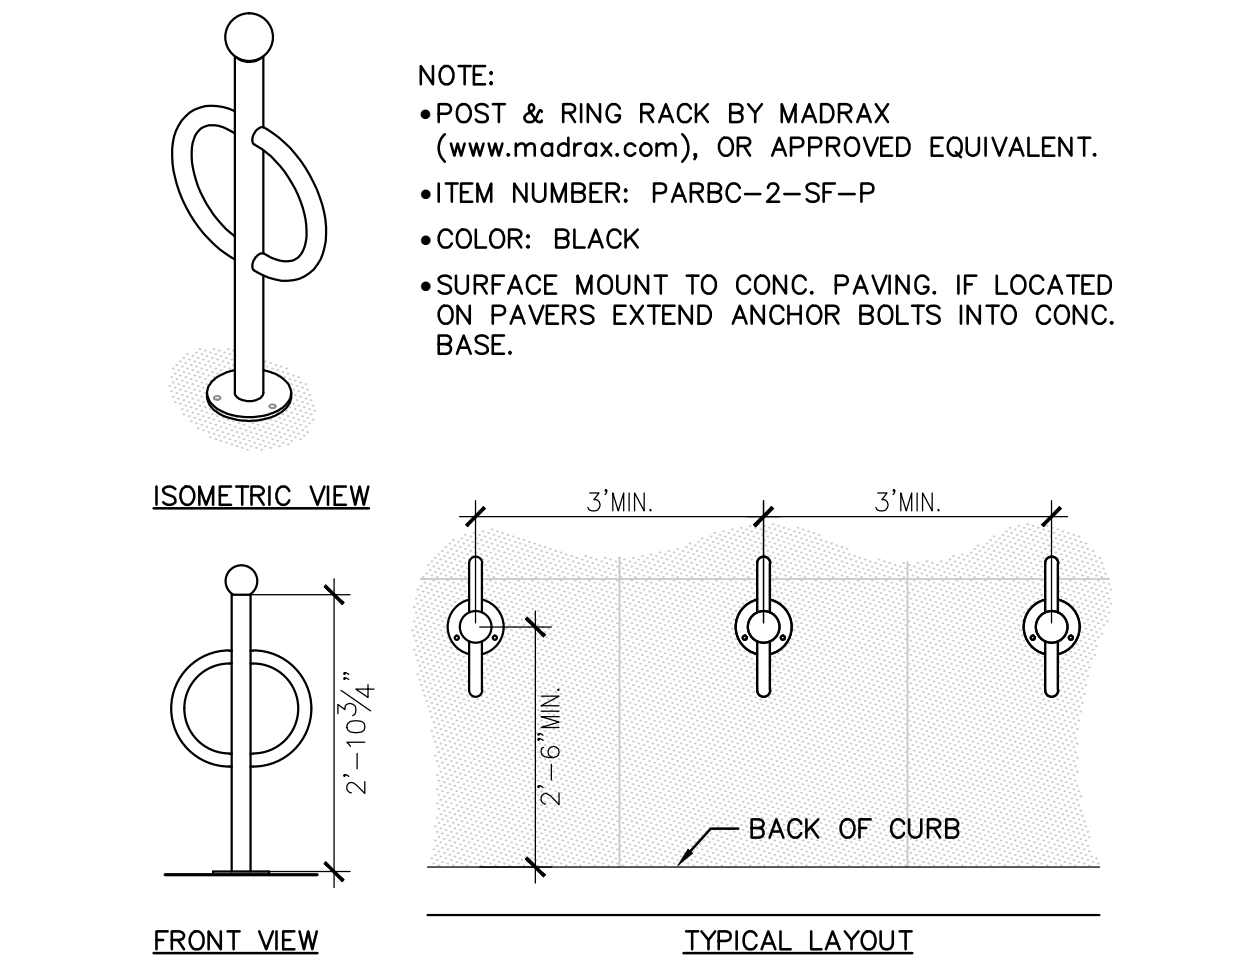
9 BIKE RACK B
 POST AND RING

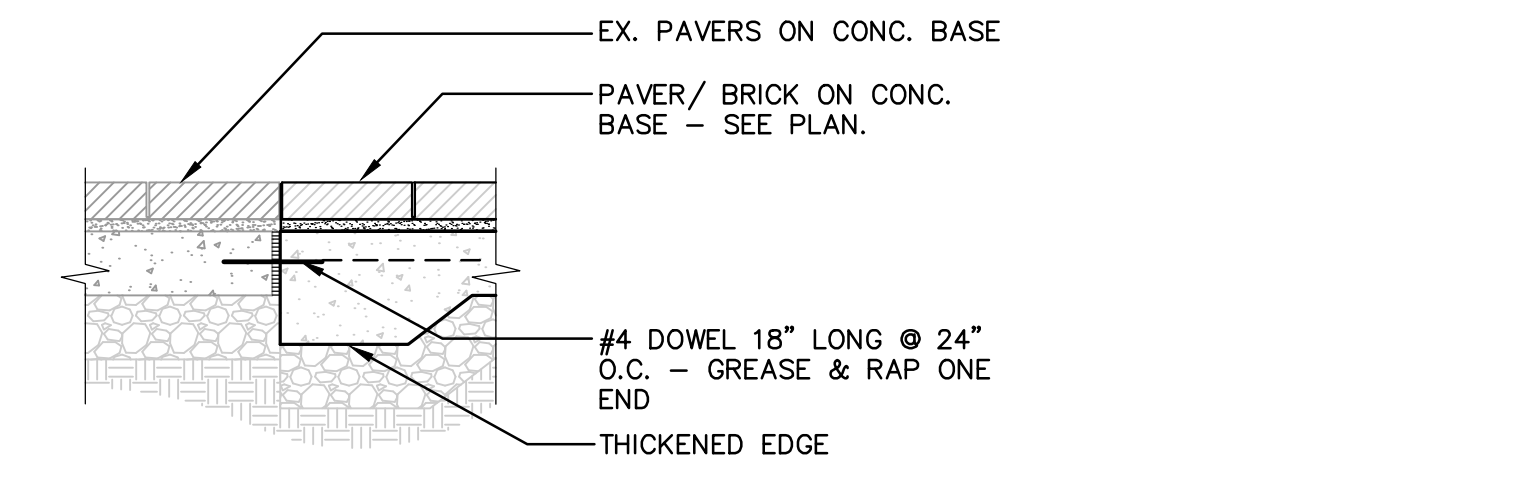
6 PAVER INTERFACE
 TYPICAL INSTALLATION OF EXISTING PAVERS TO PROPOSED PAVERS
 1" = 1'-0"

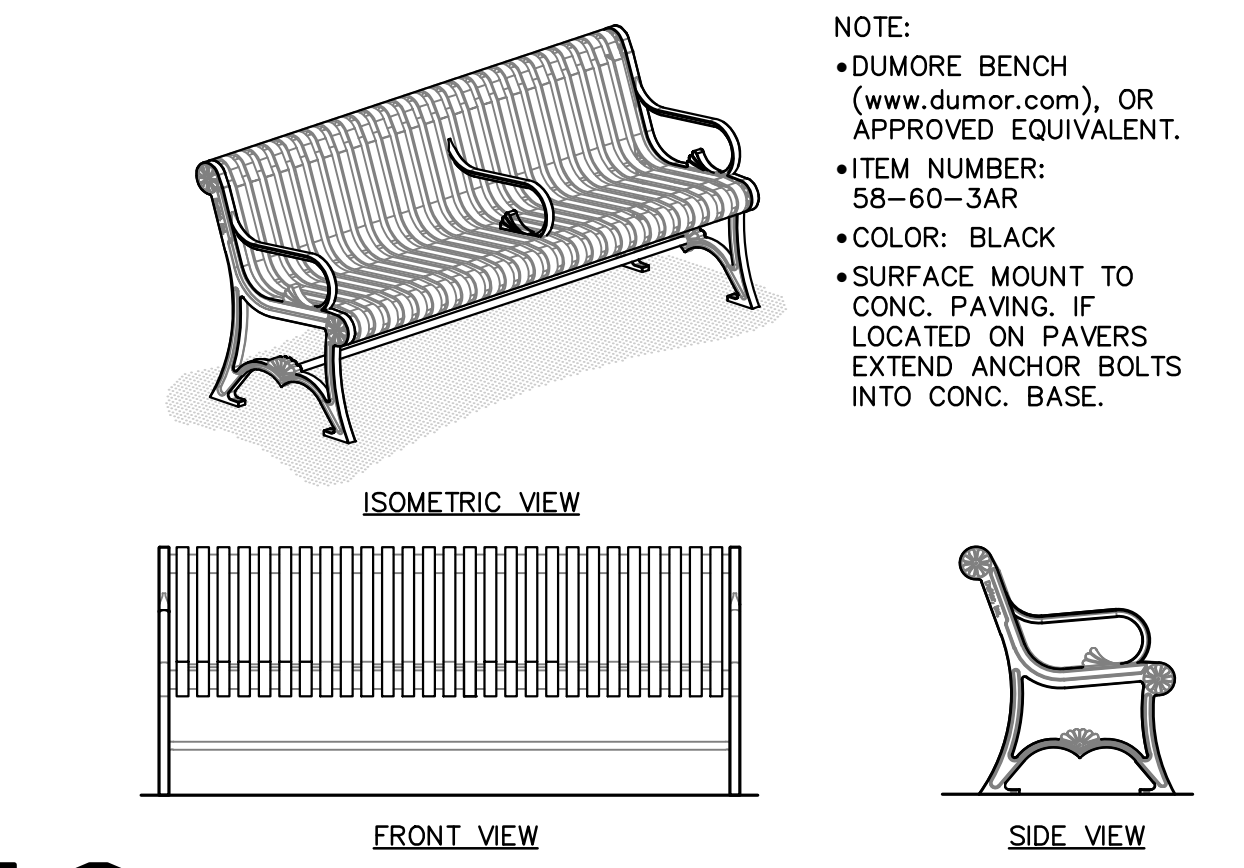
10 BENCH - BACKED

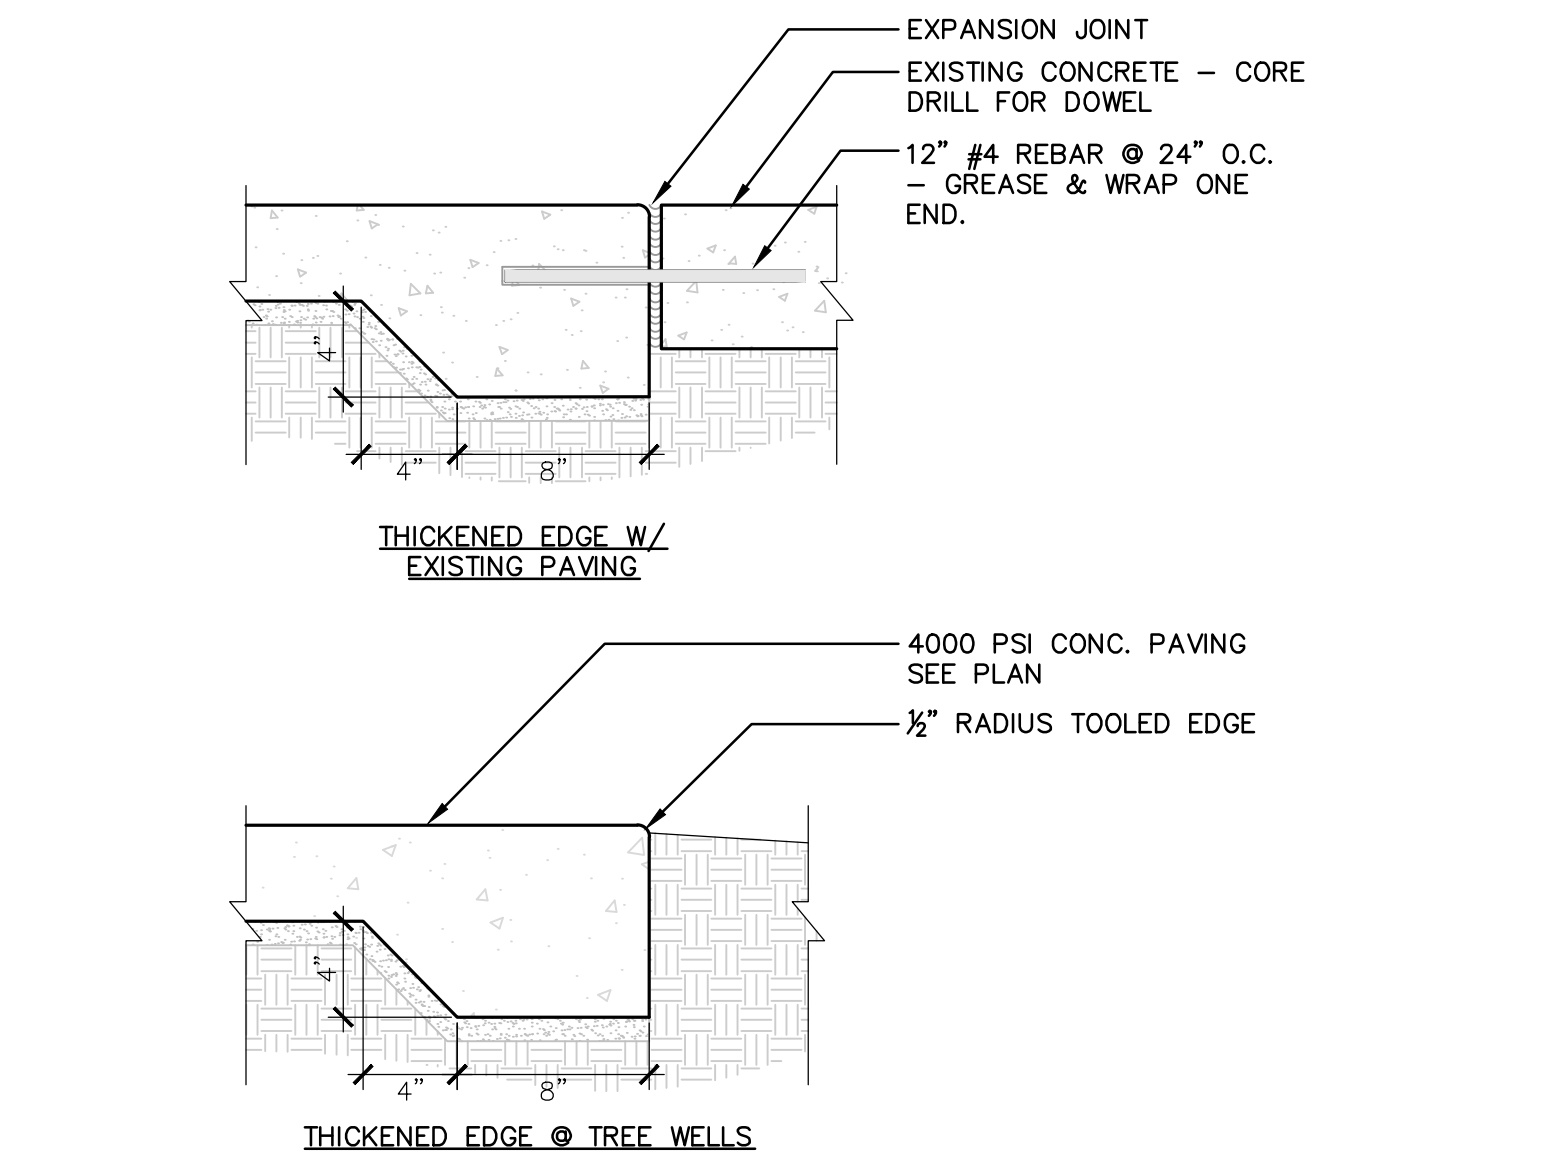
3 SIDEWALK THICKENED EDGE
 1 1/2" = 1'-0"

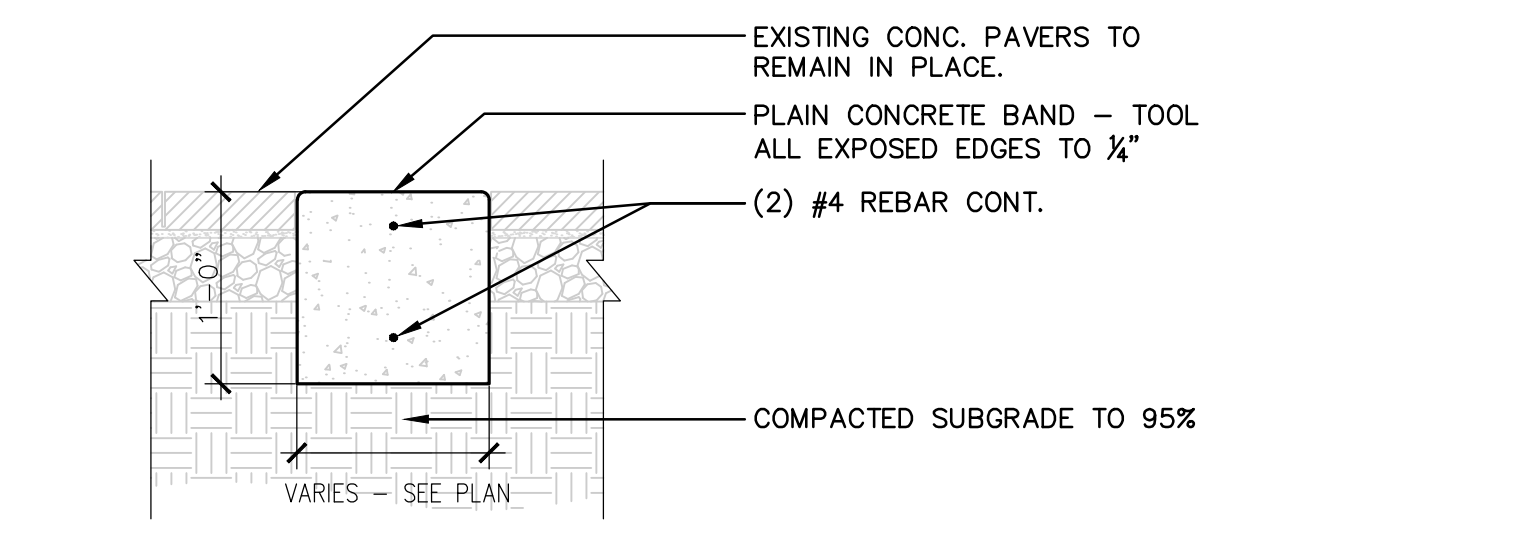
7 REINFORCED CONCRETE BAND
 1" = 1'-0"

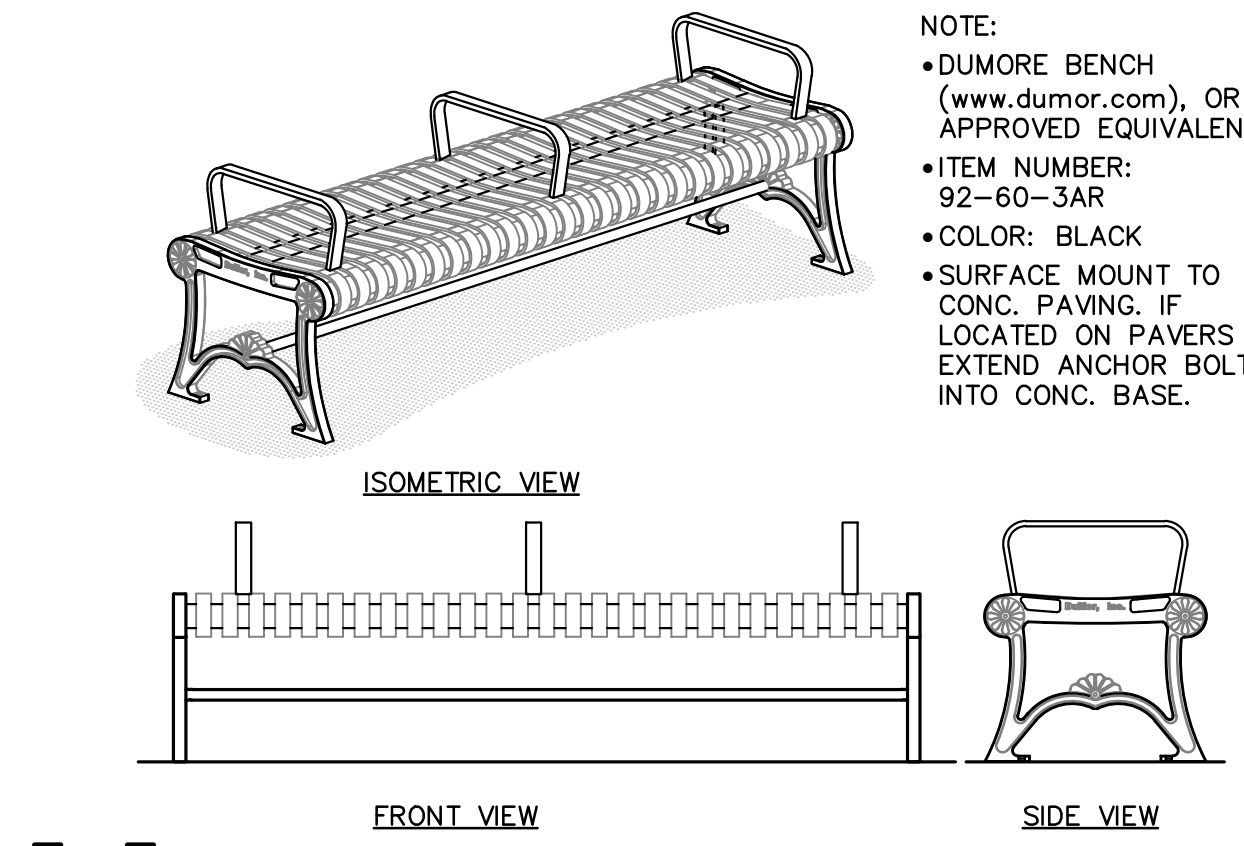
11 BENCH - BACKLESS
