Cross Sec. N From Maple St. on Maize Road (East Side only)

Cross Sectional Areas of Drainage way on east side of Maize Rd of Maple

Oak Cliff Estates Addn

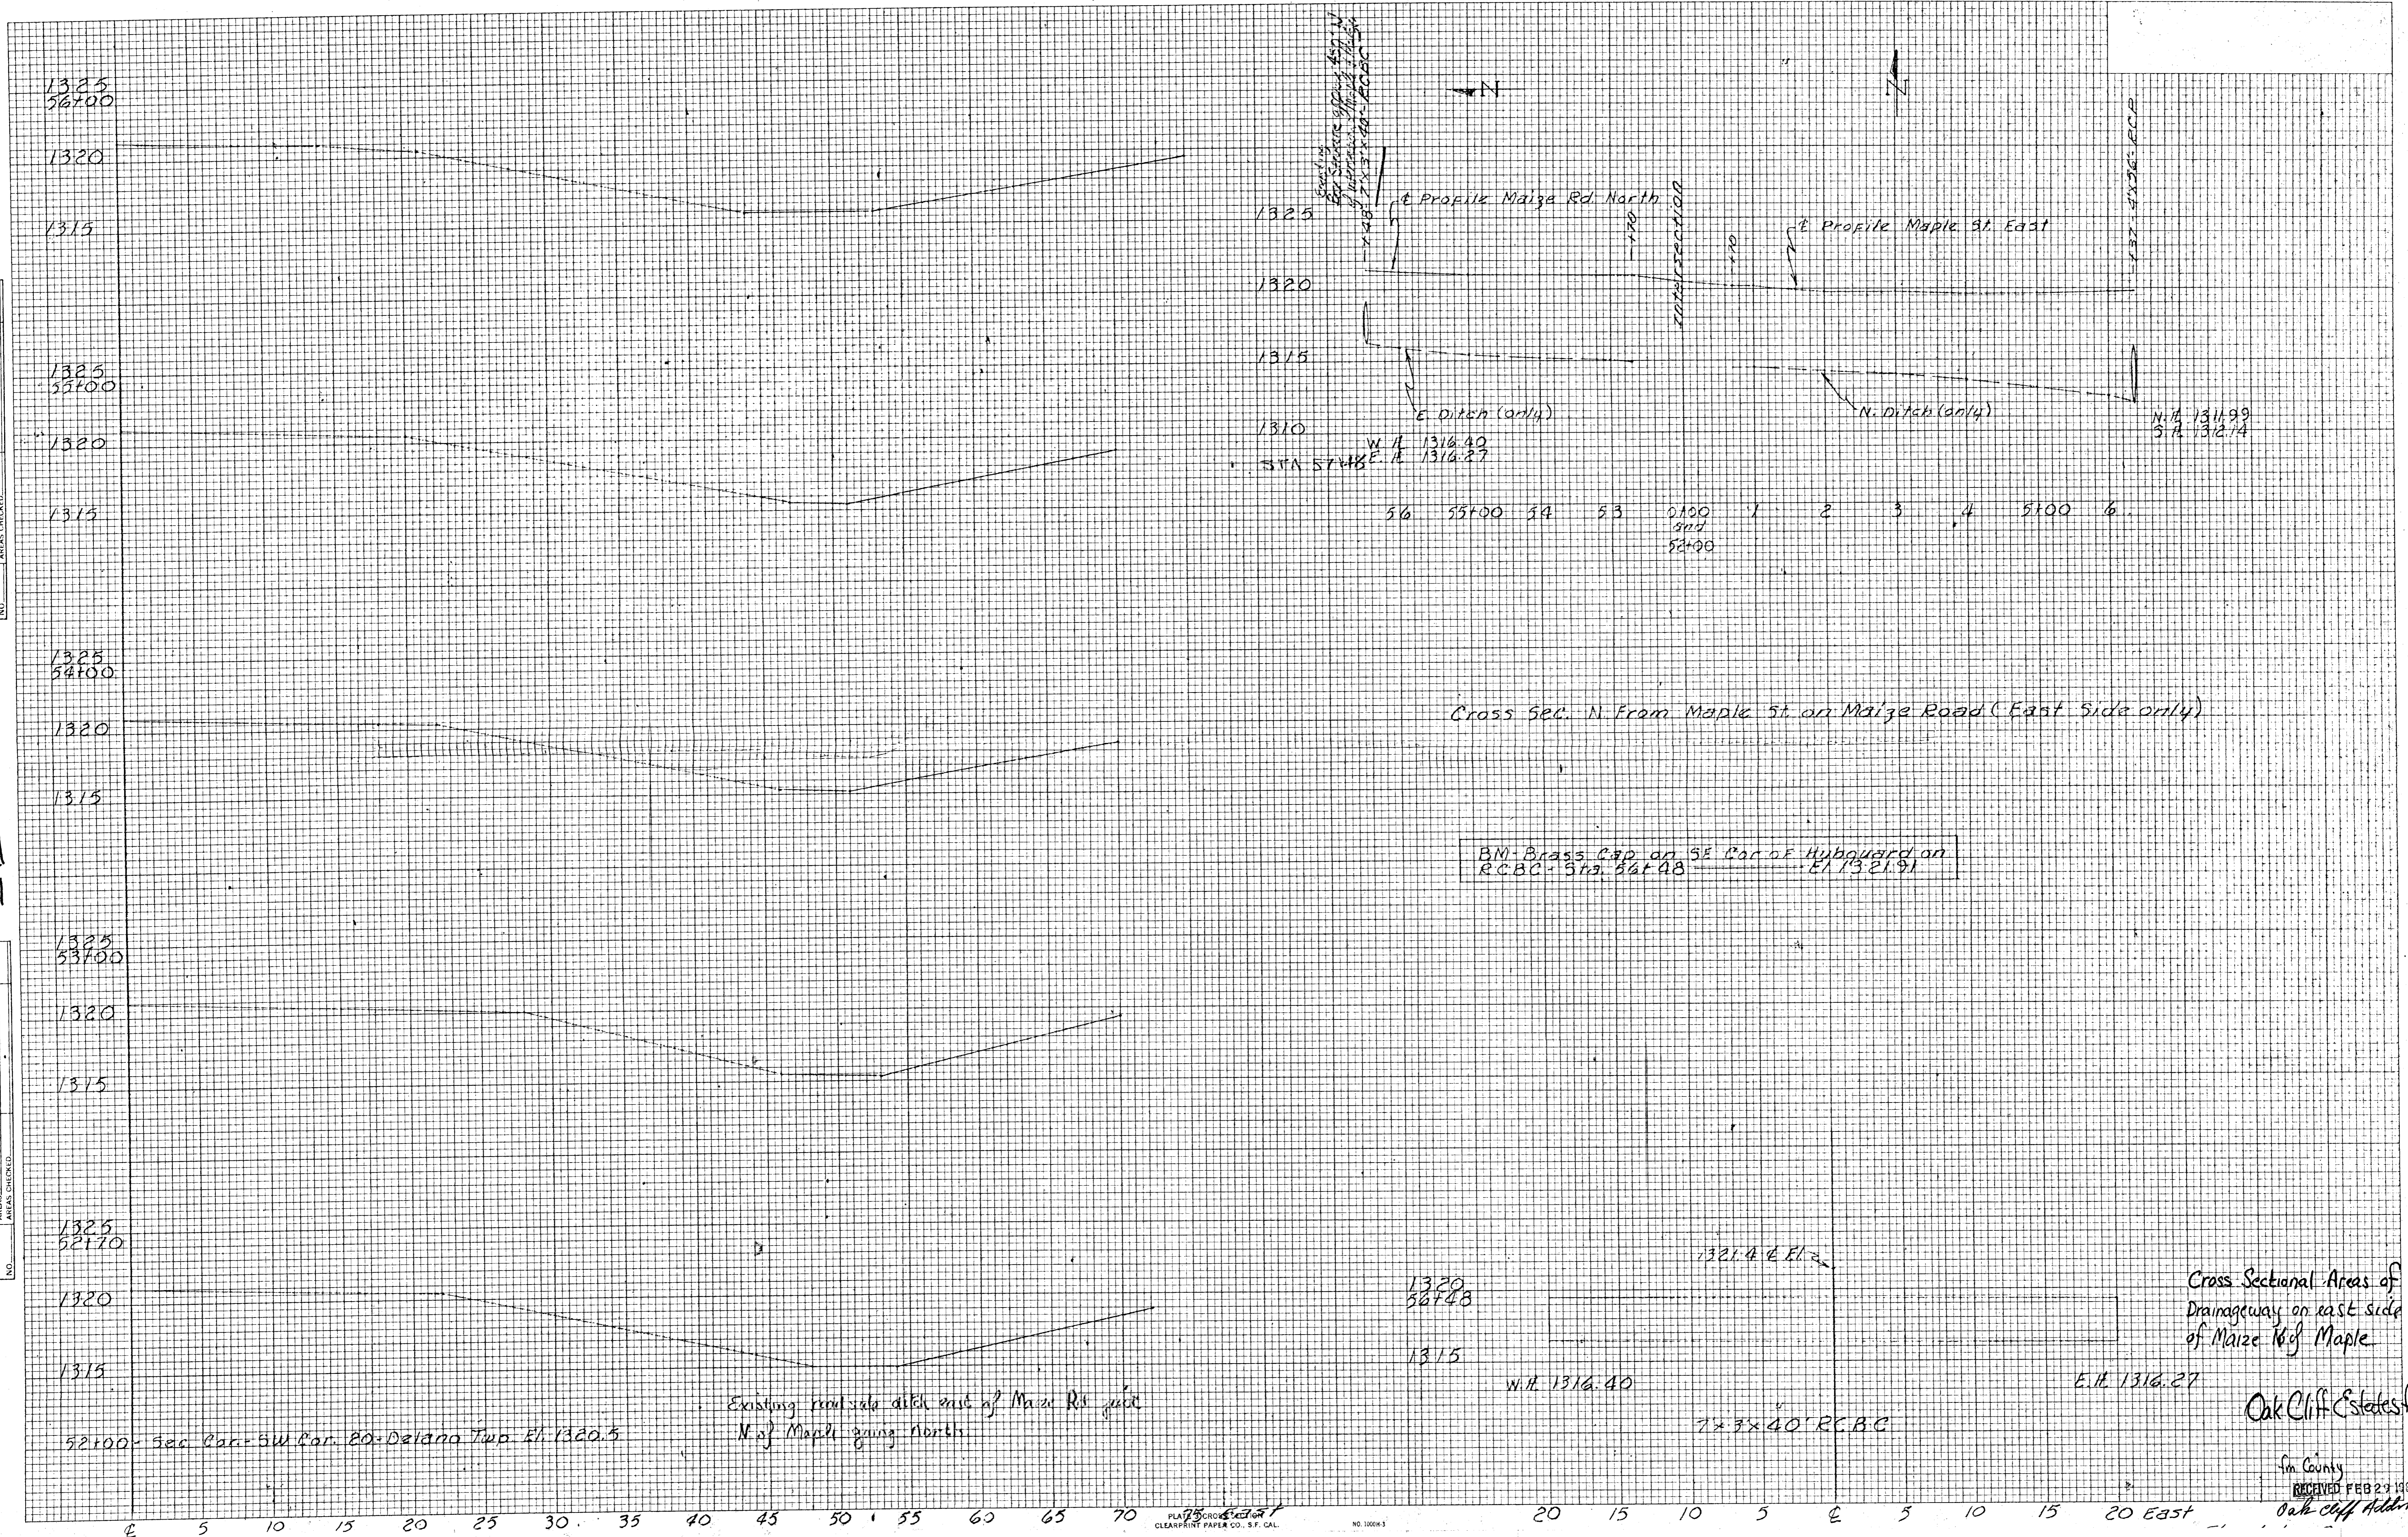
52+00 - Sec Cor - SW Cor - 20 - Delano Twp - El. 1320.5

Existing road side ditch east of Maize Rd just N of Maple going North

BM Brass Cap on SE Cor of Hubward on RCBC - Sta. 56+48 - El. 1321.91

7' x 3' x 40" RCBC
