2023-001543

Service Valve 214' N of $\frac{1}{2}$ of 18th
3' E of W.C.L. Looking East

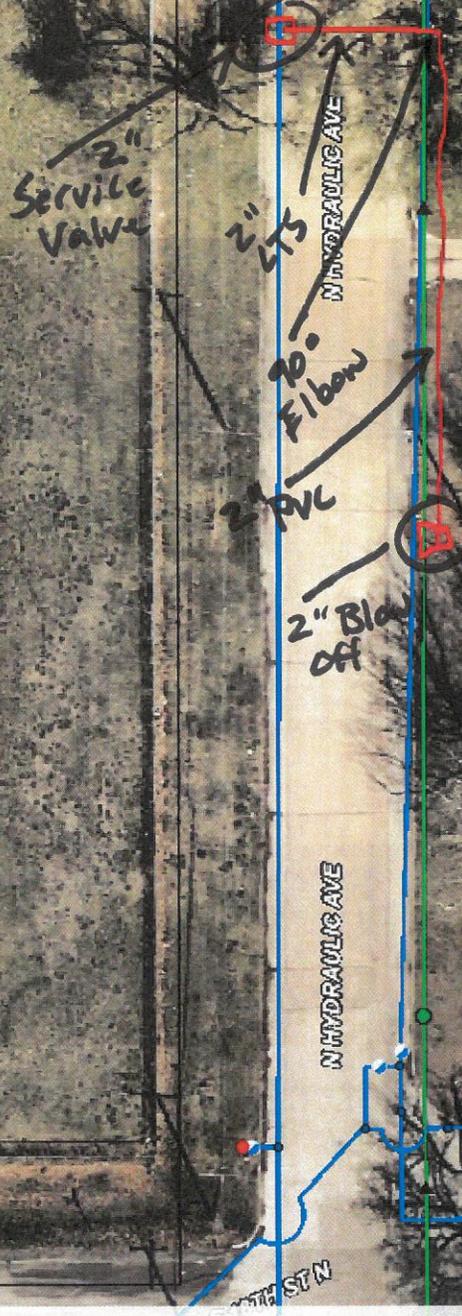
Blow off 131' N of $\frac{1}{2}$ of 18th Looking East
~~215' N~~ There is 30' of 2" LTS from top
going East. to 90° Brass Elbow 221' N
of $\frac{1}{2}$ of 18th Looking East. There is
90' of 2" PVC 1.5' E of E.C.L. Extending
South to Blow off

There is a Tracer wire in the
Valve Box at the top and also in
the B/O Valve Box for locating
the lines

Parts list.

- 1- 8x2 C.I Saddle
- 1- 2x2 Brass Nipple
- 2- 2" Curb Stops
- 1- 2" Brass Elbow
- 1- 2" PVC to Iron
- 1- 2" LTS to Iron
- 30' 2" LTS
- 90' 2" PVC
