# DRAINAGE PLAN

## ASCENSION LUTHERAN CHURCH 2ND ADDITION

### WICHITA, SEDGWICK COUNTY, KANSAS

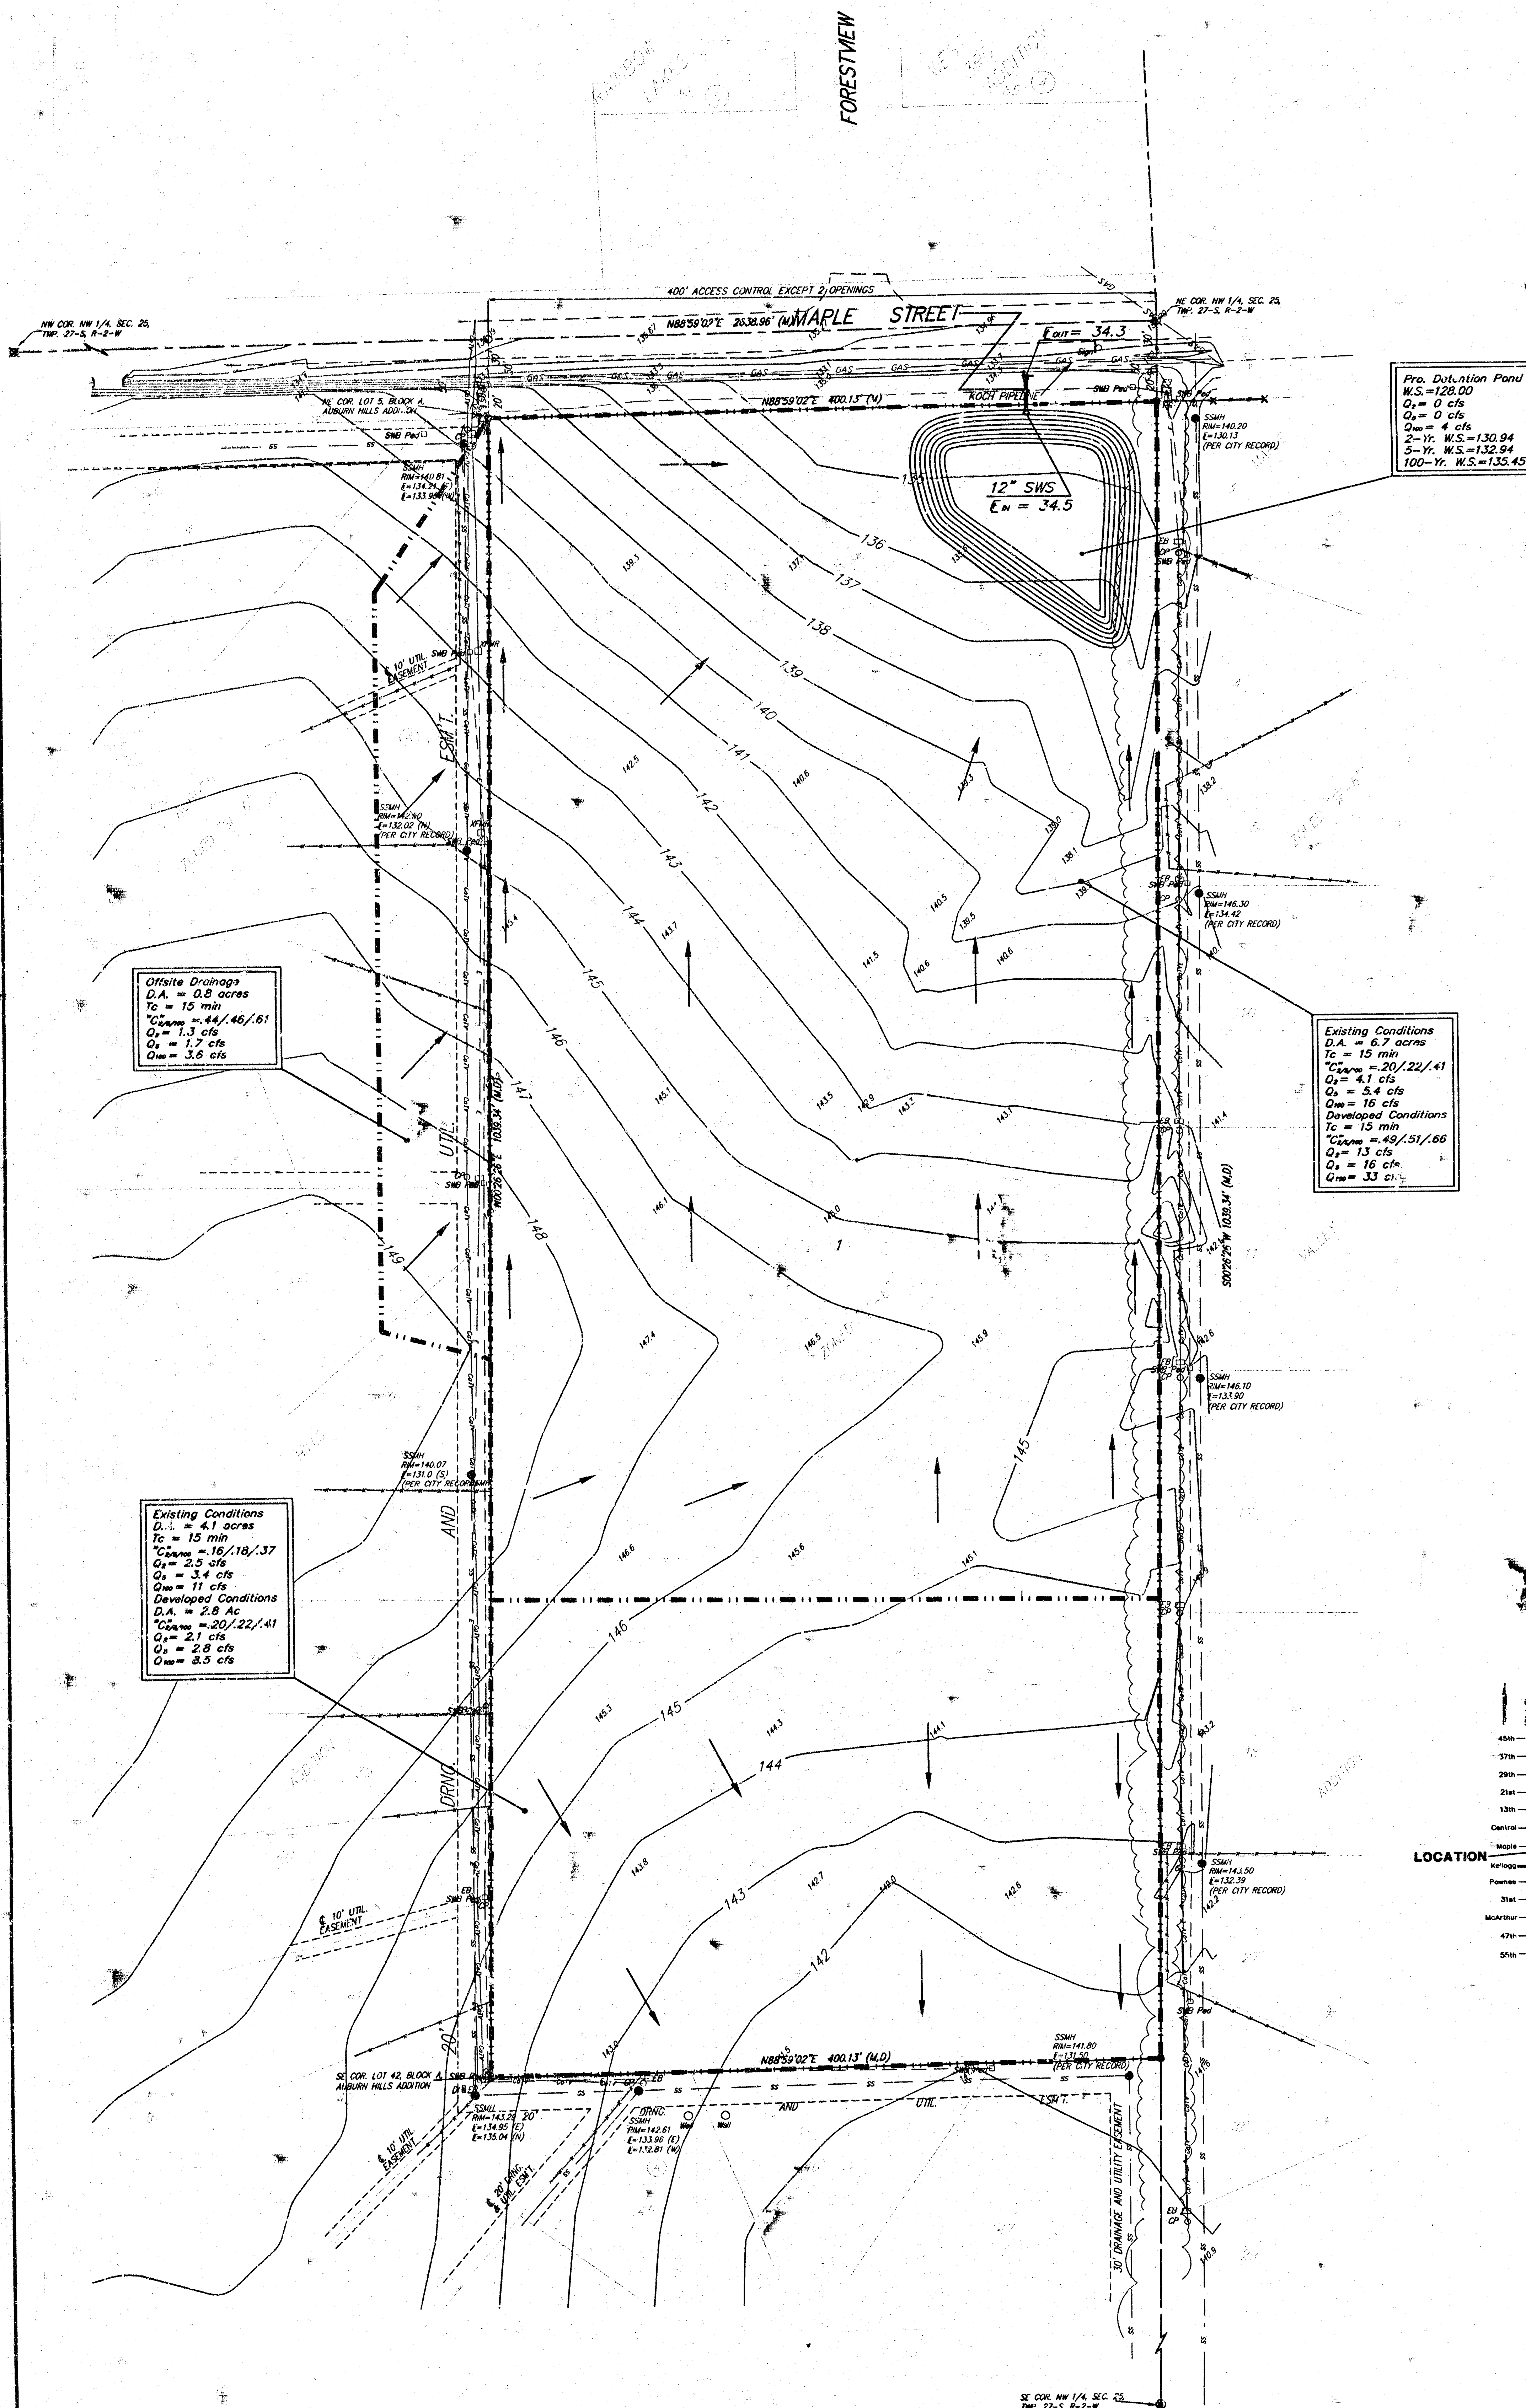
**Prop. Detention Pond**  
 W.S.=128.00  
 Q<sub>1</sub>= 0 cfs  
 Q<sub>2</sub>= 0 cfs  
 Q<sub>3</sub>= 4 cfs  
 2-Yr. W.S.=130.94  
 5-Yr. W.S.=132.94  
 100-Yr. W.S.=135.45

**Offsite Drainage**  
 D.A. = 0.8 acres  
 T<sub>c</sub> = 15 min  
 C<sub>sum</sub> = 44/46/61  
 Q<sub>1</sub> = 1.3 cfs  
 Q<sub>2</sub> = 1.7 cfs  
 Q<sub>3</sub> = 3.6 cfs

**Existing Conditions**  
 D.A. = 6.7 acres  
 T<sub>c</sub> = 15 min  
 C<sub>sum</sub> = 20/22/41  
 Q<sub>1</sub> = 4.1 cfs  
 Q<sub>2</sub> = 3.4 cfs  
 Q<sub>3</sub> = 16 cfs  
**Developed Conditions**  
 T<sub>c</sub> = 15 min  
 C<sub>sum</sub> = 49/51/66  
 Q<sub>1</sub> = 13 cfs  
 Q<sub>2</sub> = 16 cfs  
 Q<sub>3</sub> = 33 cfs

**Existing Conditions**  
 D.A. = 4.1 acres  
 T<sub>c</sub> = 15 min  
 C<sub>sum</sub> = 16/18/37  
 Q<sub>1</sub> = 2.5 cfs  
 Q<sub>2</sub> = 3.4 cfs  
 Q<sub>3</sub> = 11 cfs  
**Developed Conditions**  
 D.A. = 2.8 Ac  
 C<sub>sum</sub> = 20/22/41  
 Q<sub>1</sub> = 2.7 cfs  
 Q<sub>2</sub> = 2.8 cfs  
 Q<sub>3</sub> = 8.5 cfs

**Dr. Note:**  
 Soil Type: Vanoss (B) / Hydrologic Group "B"
