**BRIDGE DECK RECONSTRUCTION**  
**13TH ST. OVER THE ARKANSAS RIVER**

**DETAILS**

SHEET  
**3**  
OF 6

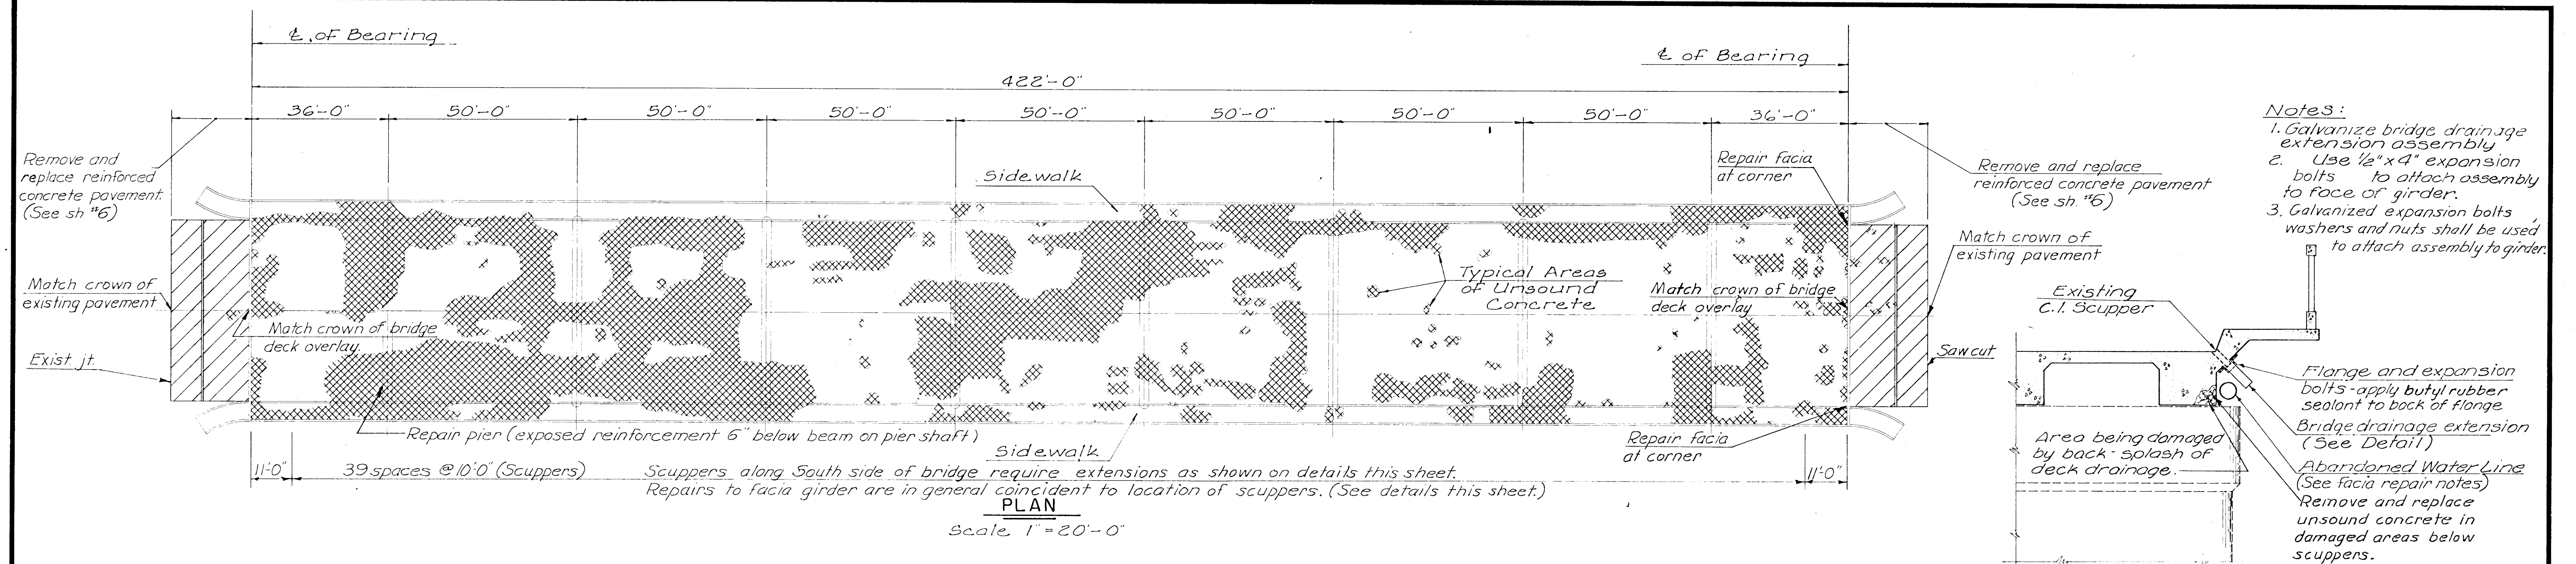
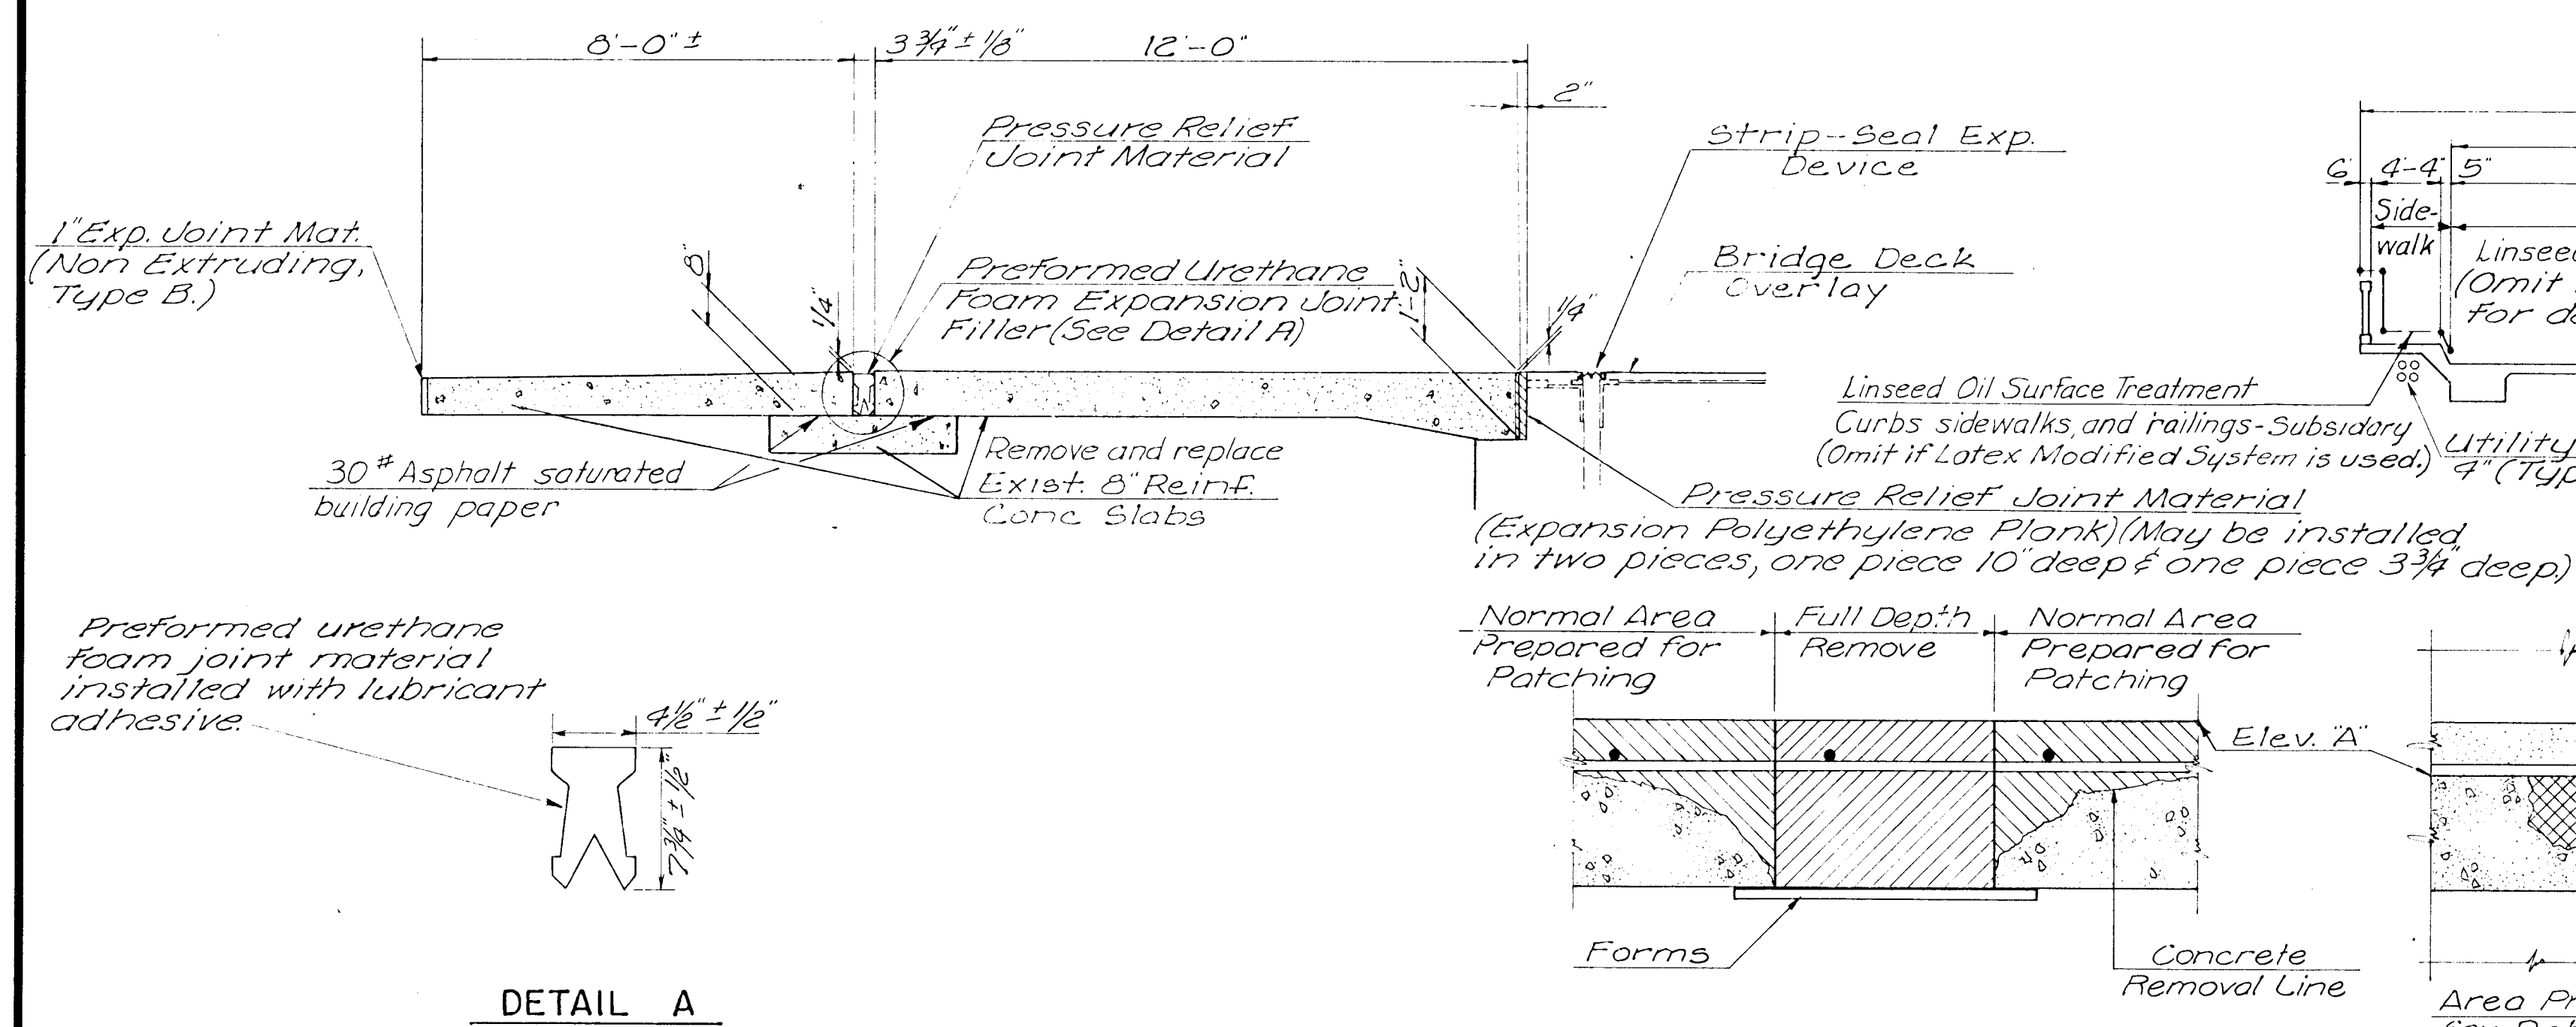
**REPAIRS TO APPROACH SLAB**  
**EXPANSION DEVICE**
