| <b>Baughman</b> | | <b>STEVE KELLEY 5TH ADDITION</b> | |
| <b>LINE 3</b> | | <b>STORM WATER SEWER IMPROVEMENTS</b> | |
| SCALE<br>Noted<br>SHEET | | <b>11 OF 25</b> | |

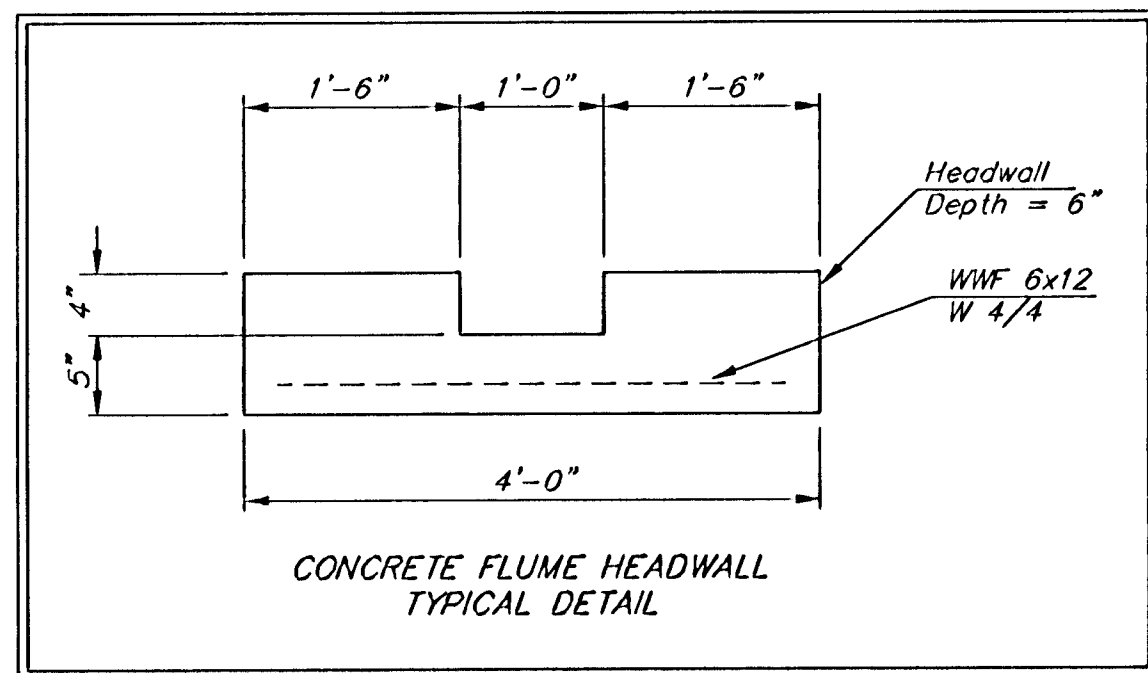
**NOTE:**  
Groove flume longitudinally every  
4 feet. Install expansion joint  
every 100 feet.

Scale: 1" = 20' Horizontal  
1" = 5' Vertical  
• = Iron
