Install 299 lf of 8" Cured-in-Place Liner

Television Inspection Master Report

US Structure: 6047-241
DS Structure: 6047-240

8020 E LYNNWOOD ST
145 S LOCHINVAR DR

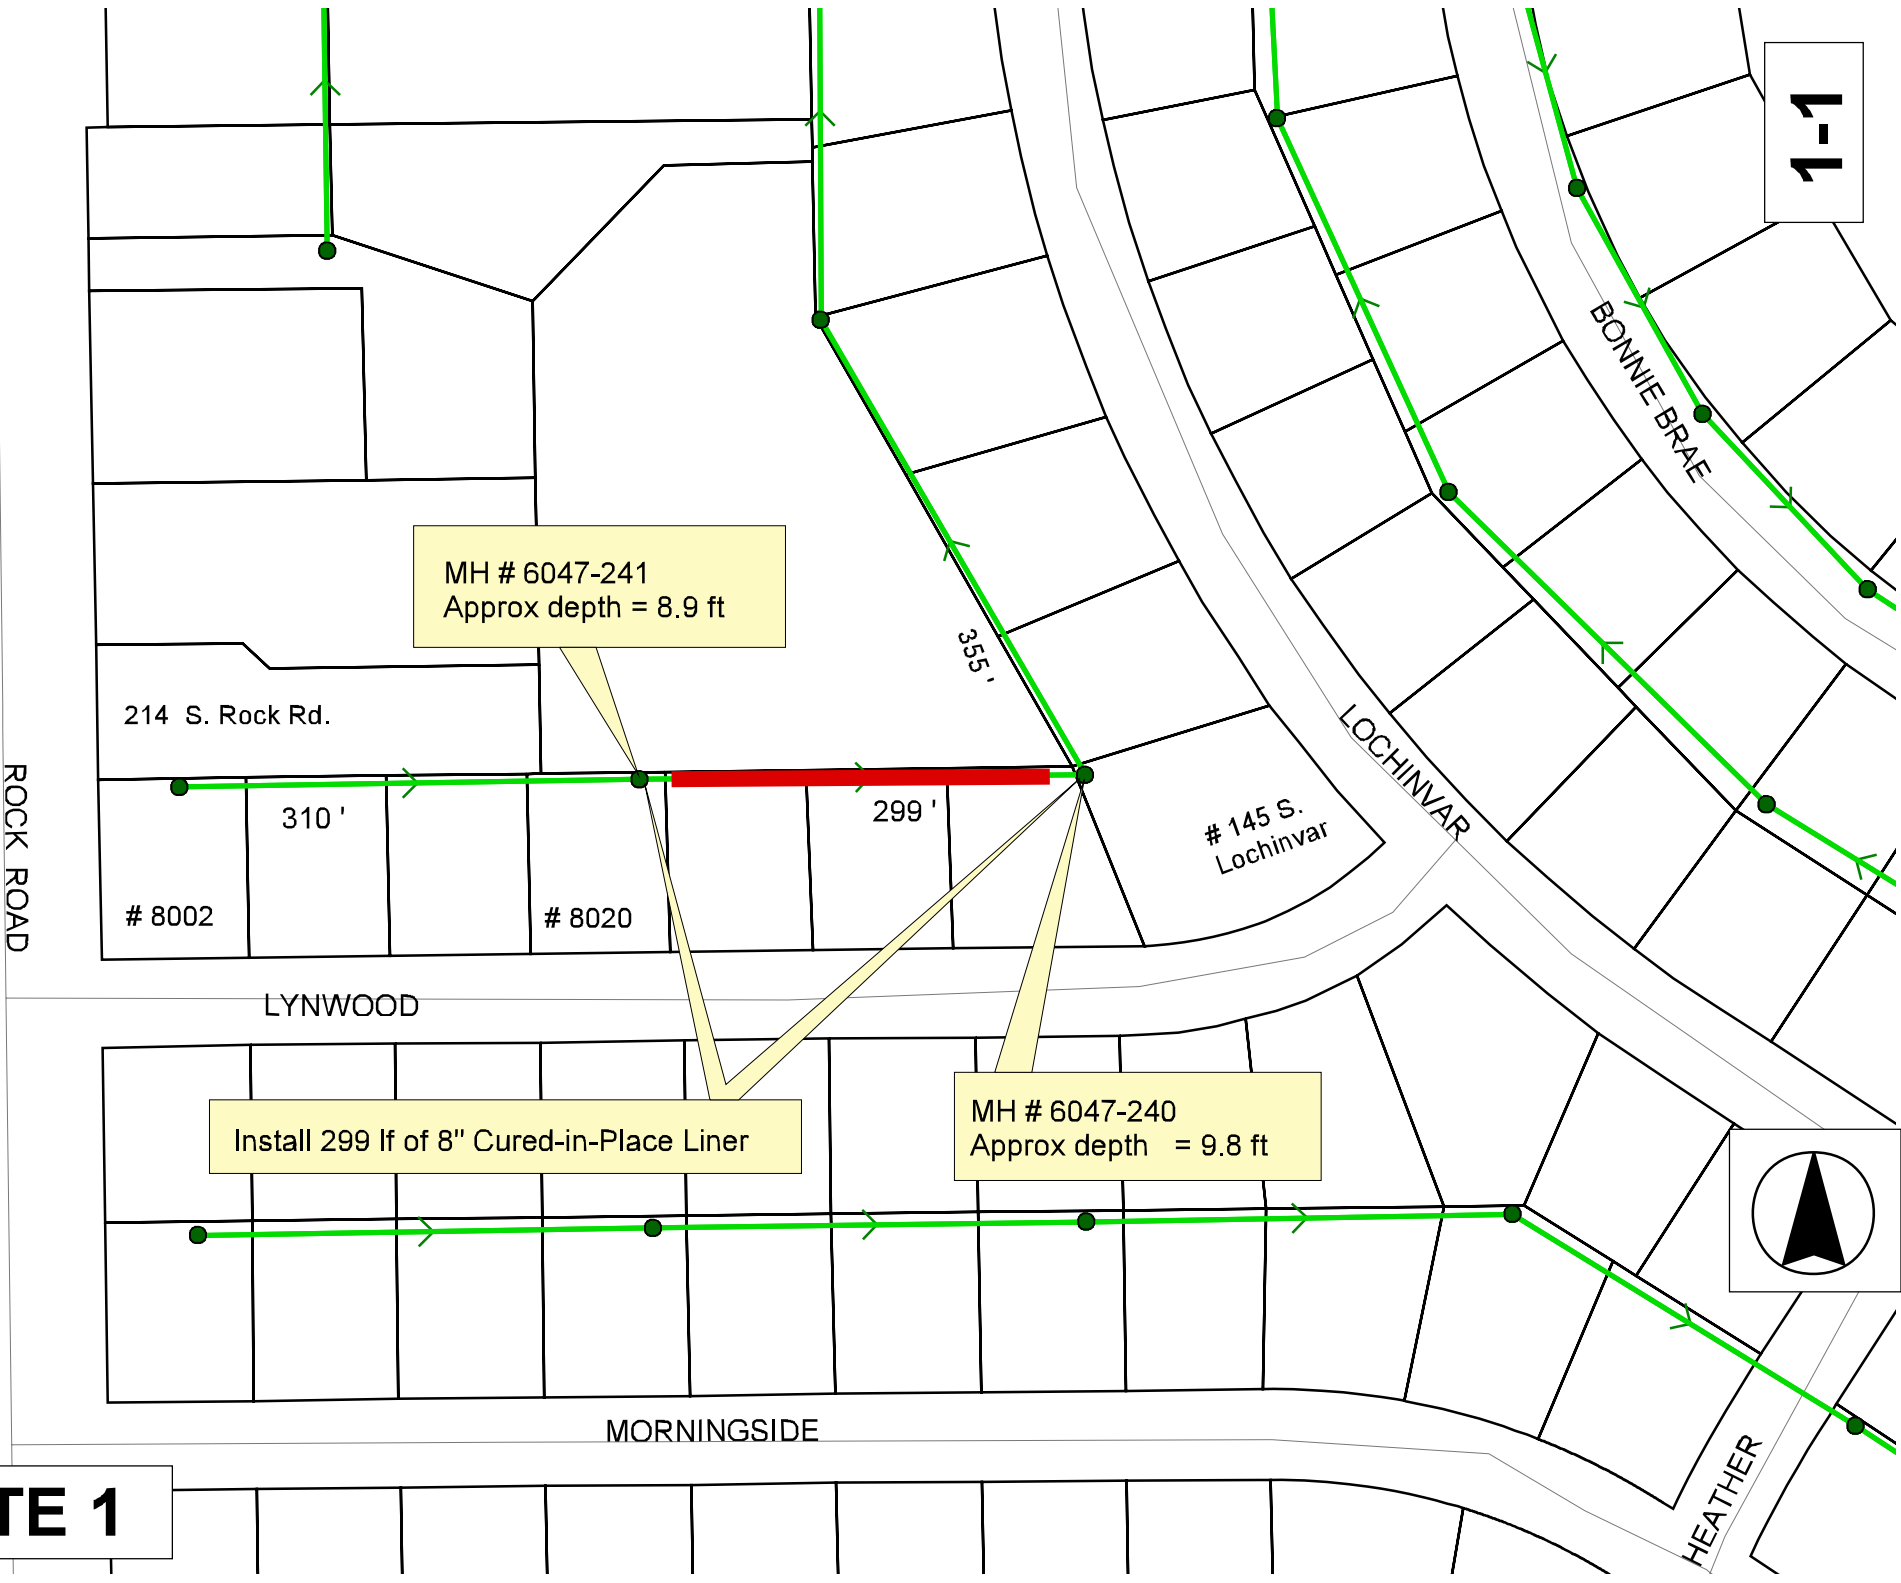
Aerial View

MH # 6047-241
Approx depth = 8.9 ft

MH # 6047-240
Approx depth = 9.8 ft

Line has a lot of small offset joints.
