Install 239 lf of 8"
Cured-in-Place Liner

SITE 7

Television Inspection Master Report

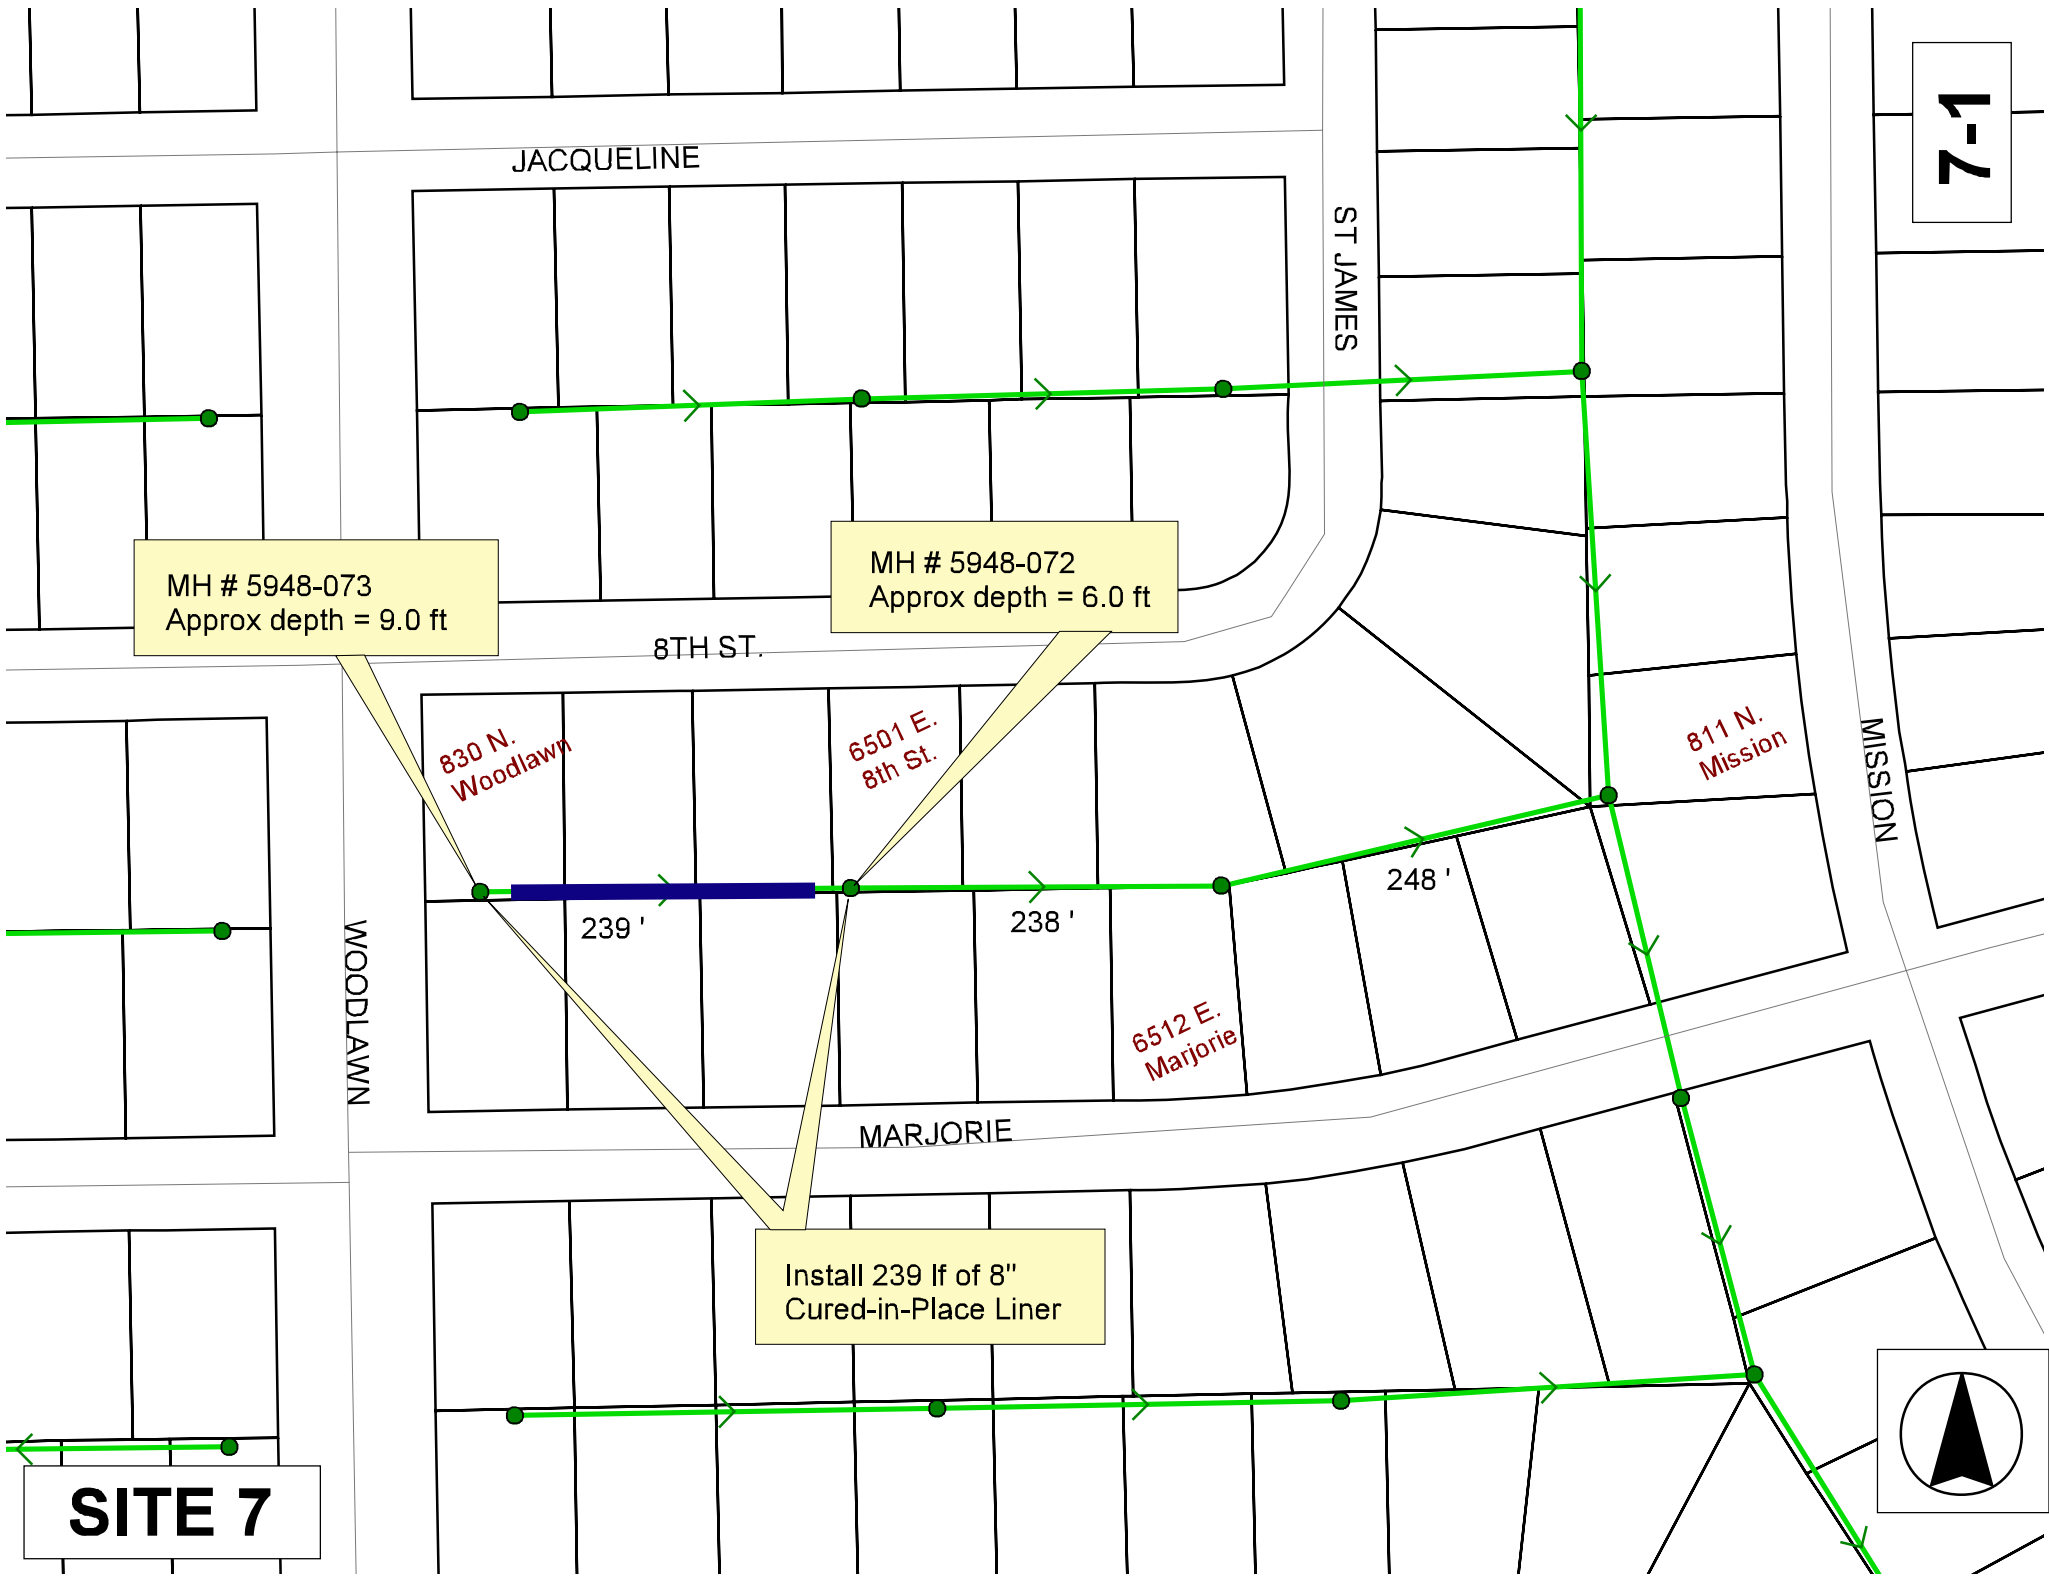
Aerial View

MH # 5948-073
Approx depth = 9.0 ft

MH # 5948-072
Approx depth = 6.0 ft

Obs. #	VTR #	Counter Comment	Distance	Location	Description	Rating	Obsrvd (gpm)	Est. (gpm)	Ratings Struct	Clean	Remain (gpm)
1			0.0	US Manhole 5948-073	(NOTE: large concrete pad for RV parking is over the sewer line)

1.0	Offset Joint							
2			14.0	North	Wye Service	4					
				ROOTS 830 NORTH WOODLAWN							
3			17.0		Sealed Off Wye South	1					
4			18.0	Joint	Roots	3					
5			28.0	Upper Left	Broken Pipe	3					
6			31.0	Crown	Broken Pipe	3					
7			34.0	Crown	Crack-Horizontal	3					
8			36.0	Crown	Crack-Horizontal	3					
9			40.0	Joint	Roots	3					
10			40.0	Crown	Broken Pipe	3					
11			43.0	Crown	Broken Pipe	4					
12			44.0	South	Break-In Conn / Roots	5					
13			45.0	Crown	Broken Pipe	4					
14			52.0	Joint	Roots	3					
15			55.0	Joint	Roots	3					
16			58.0	Joint	Roots	3					
17			114.0		Wye Service	1					
18			117.0		Wye Service / Roots	5					
19			168.0		Sealed Off Wye North	1					
20			201.0		Break-In Conn	3					
				ROOTS 6409 EAST 8TH ST. NORTH							
21			205.0	South	Wye Service	5					
				ROOTS 6420 EAST MAJORIE							
22			238.0	Joint	Offset	4					
23			238.0	DS Manhole		1					
24			238.0		Stopped Inspection	5

NOTE:
The video skips from 205' to 228' so we do not see that 23' of pipe on the video.

Obs. #	VTR #	Counter Comment	Distance	Location	Description	Rating	Obsrvd (gpm)	Est. (gpm)	Ratings Struct	Clean	Remain (gpm)
1			0.0	DS Manhole 5948-072	TELEVISIONING AGAINST THE FLOW						
					WE WILL TELEVISION APROX 3 FT TO FINISH LINE						
3			3.0	Joint	Offset	5					
					BROKEN PIPE / Stopped Inspection						
					STOPPED DUE TO OFFSET & BROKEN PIPE / TOTAL DISTANCE FOR LINE IS 239 FT

NOTE: DOWNSTREAM 10 LF OF PIPE WAS REPLACED "BY OTHERS" / PIPE STILL IN POOR COND. BUT CAN BE LINED
