DESIGN N.D. DR. BY B.E.S. CK. BY R.A.W. DATE Mar 78 JOB NO. 77-218	<b>BRIDGE DECK RECONSTRUCTION</b> 13TH ST. OVER THE ARKANSAS RIVER	
	<b>DETAILS</b>	
VAN DOREN · HAZARD · STALLINGS ARCHITECTS · ENGINEERS · PLANNERS WICHITA, KANSAS		SHEET <b>3</b> OF 6

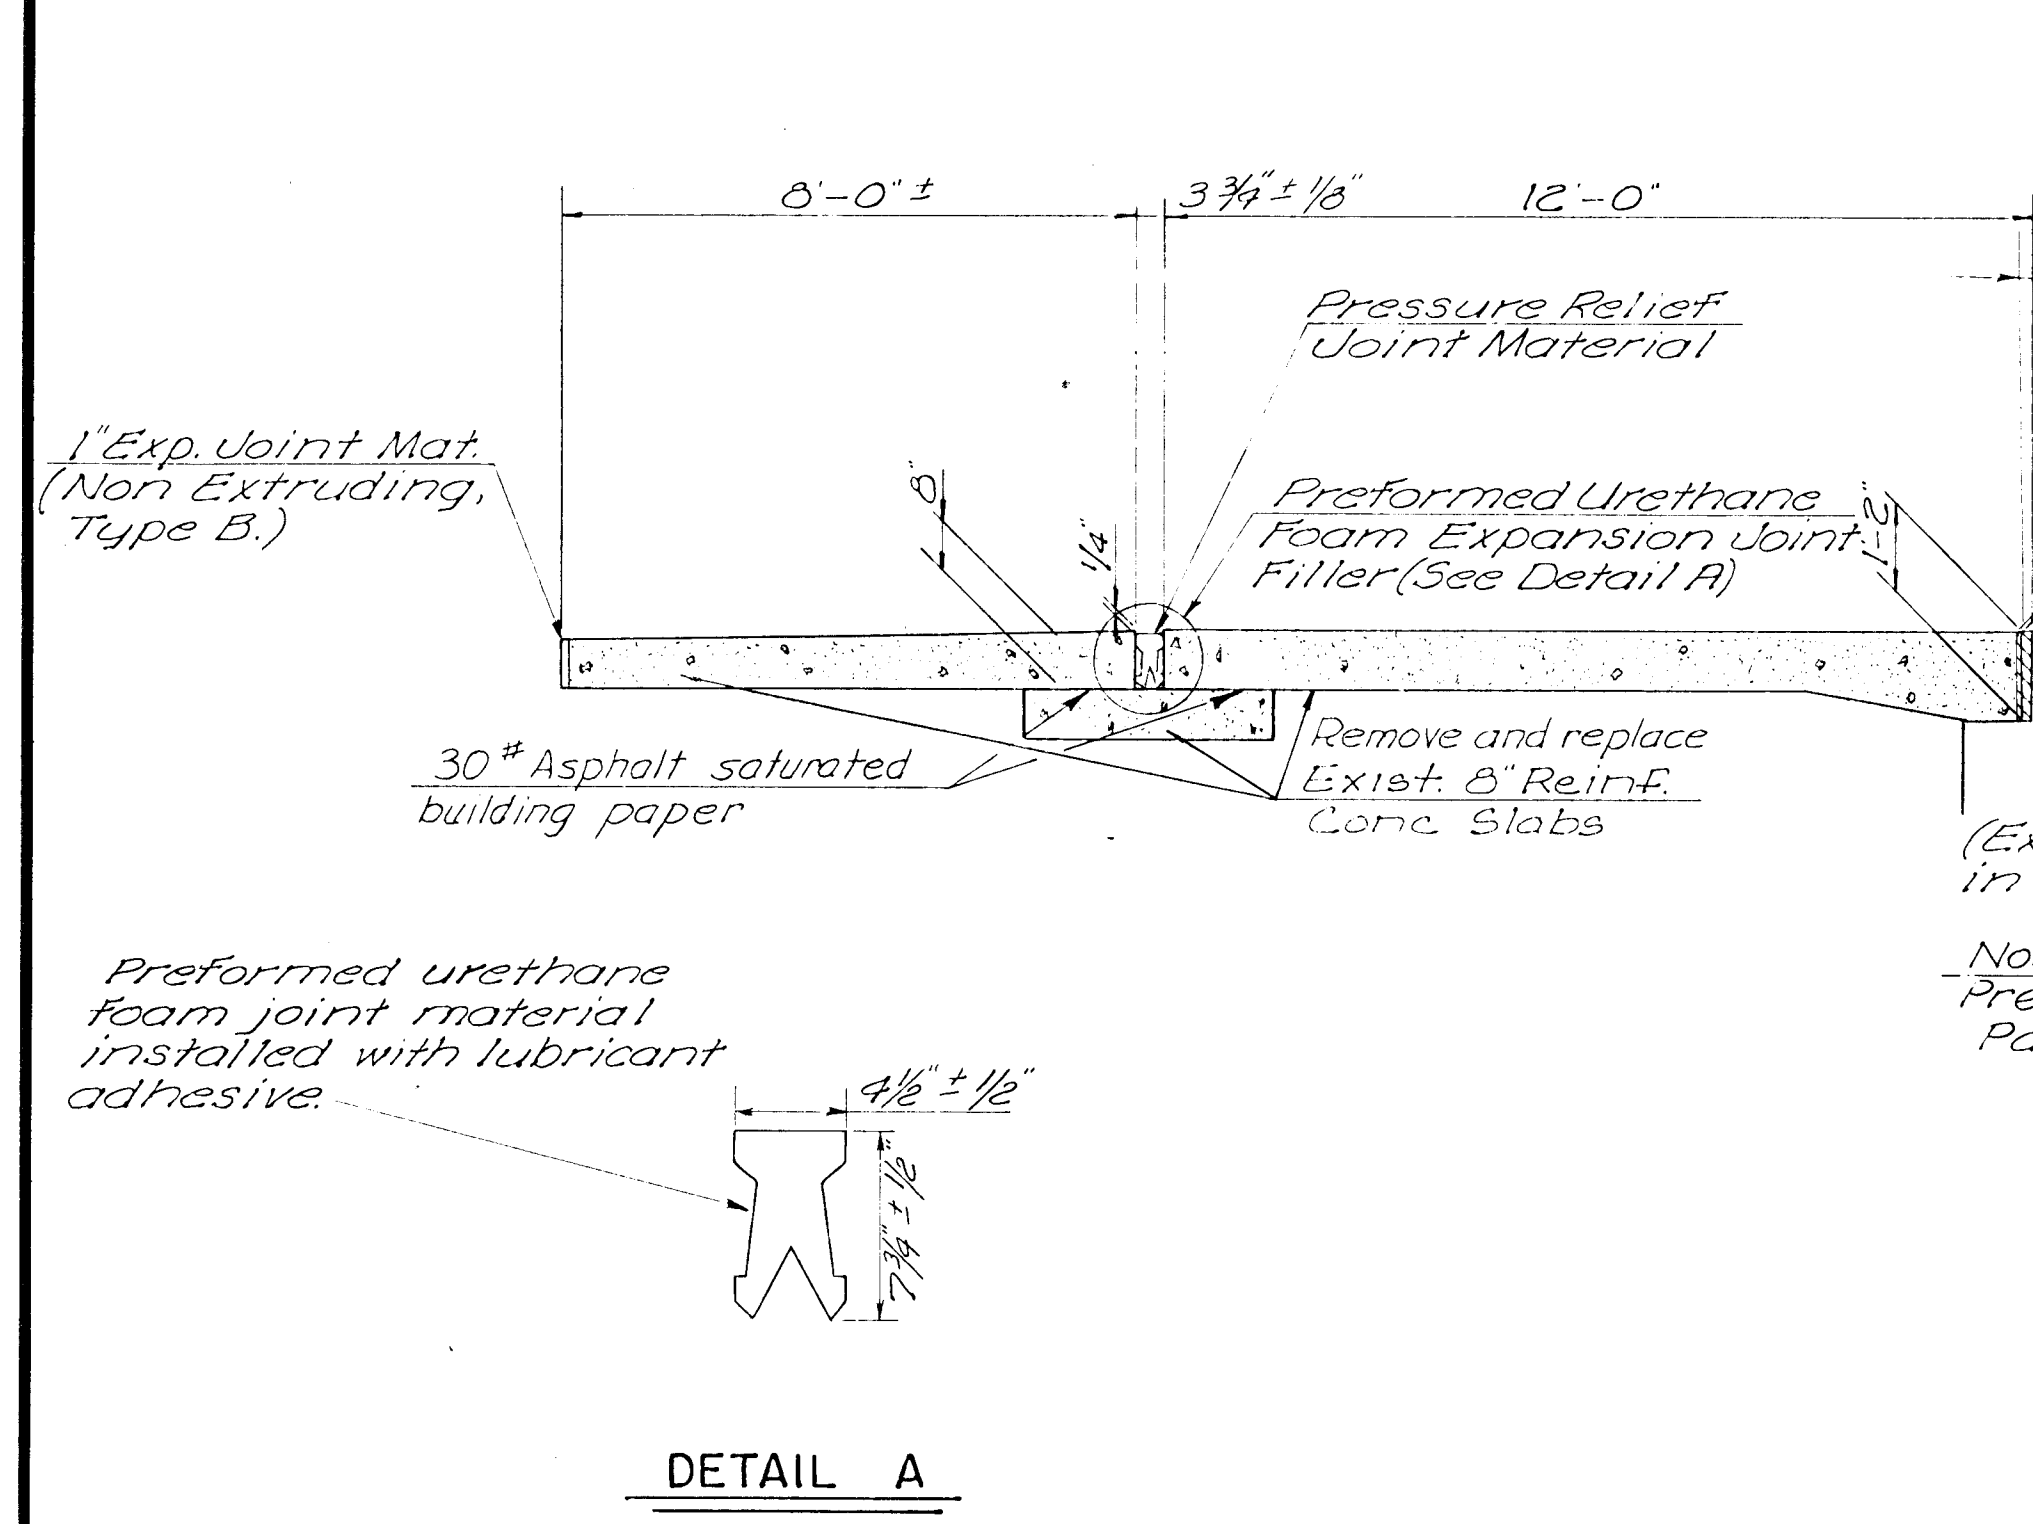
**REPAIRS TO APPROACH SLAB EXPANSION DEVICE**
