| <b>Baughman</b> | | <b>STEVE KELLEY 5TH ADDITION</b> | |
| <b>LINE 3</b> | | <b>STORM WATER SEWER IMPROVEMENTS</b> | |
| PROJECT NUMBER<br>47283993 | DESIGN<br>MWS | DRAWN<br>TMS | DATE<br>06/04 |

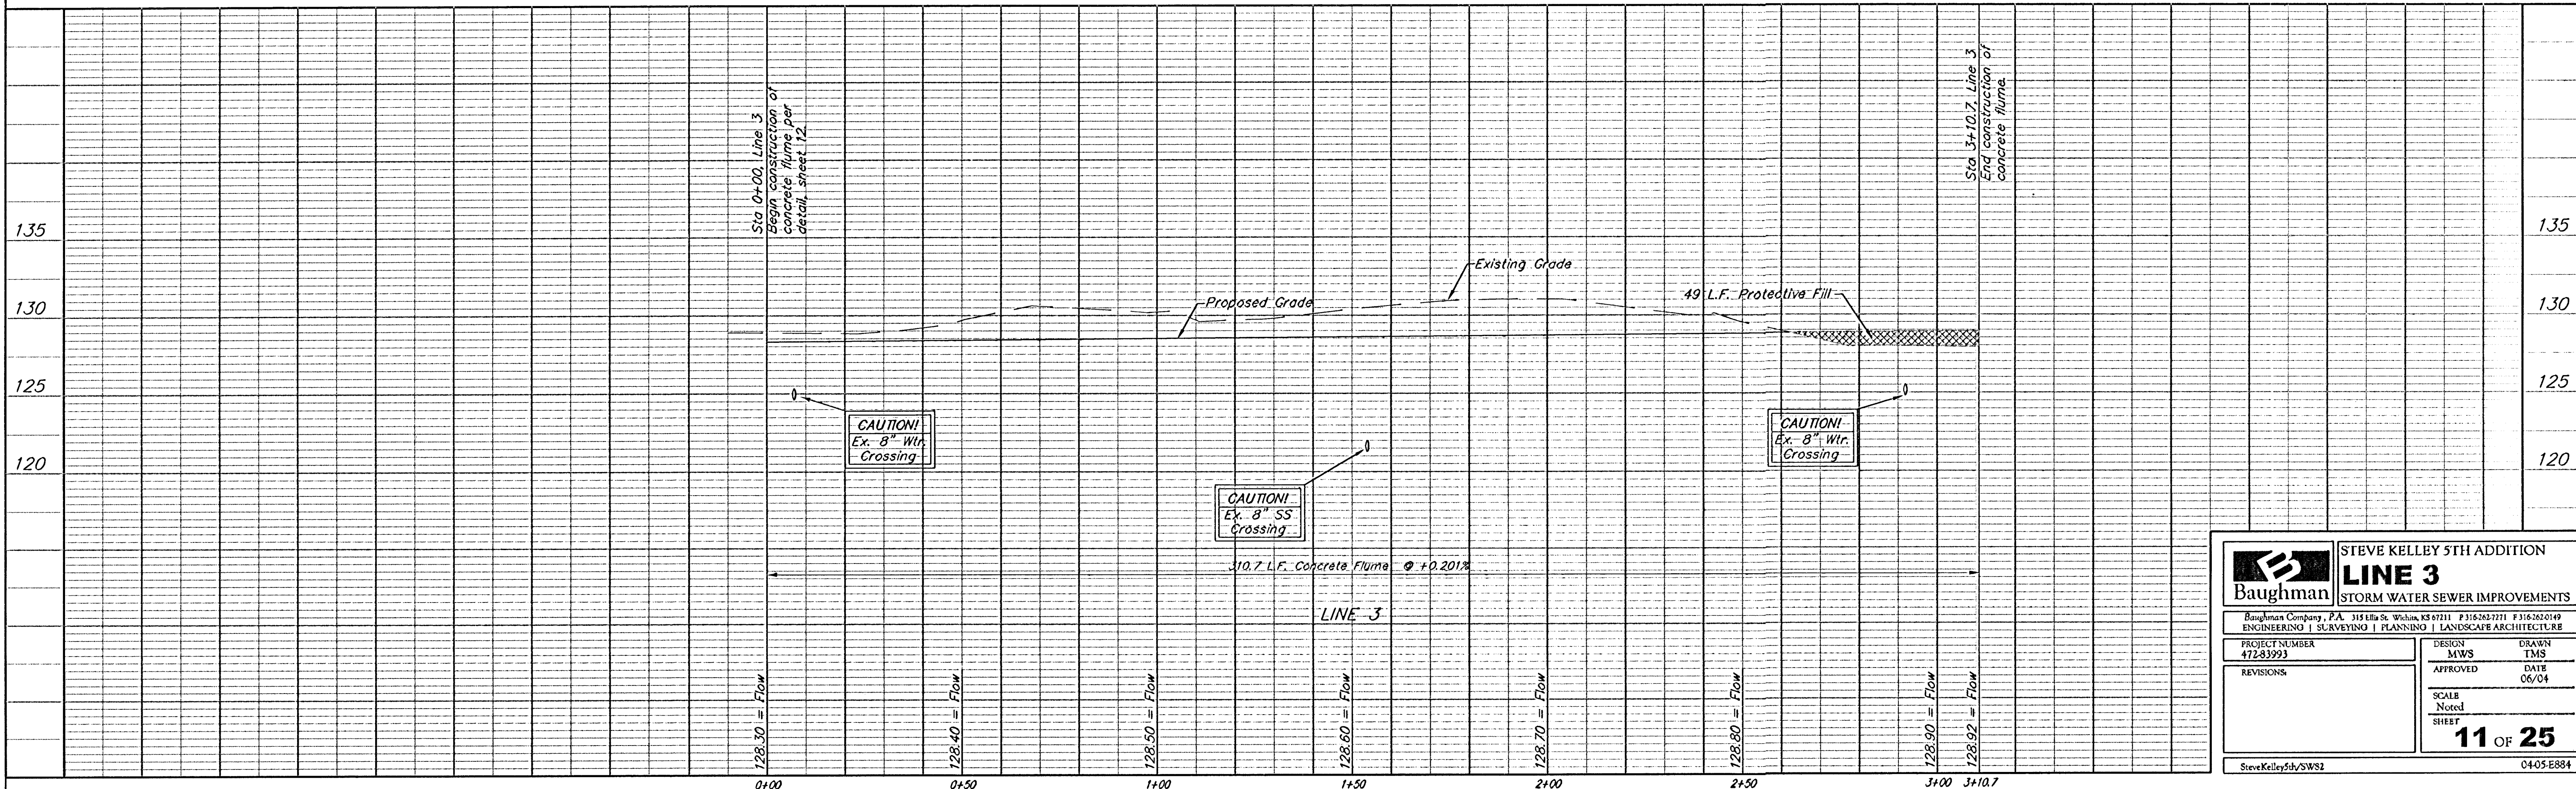
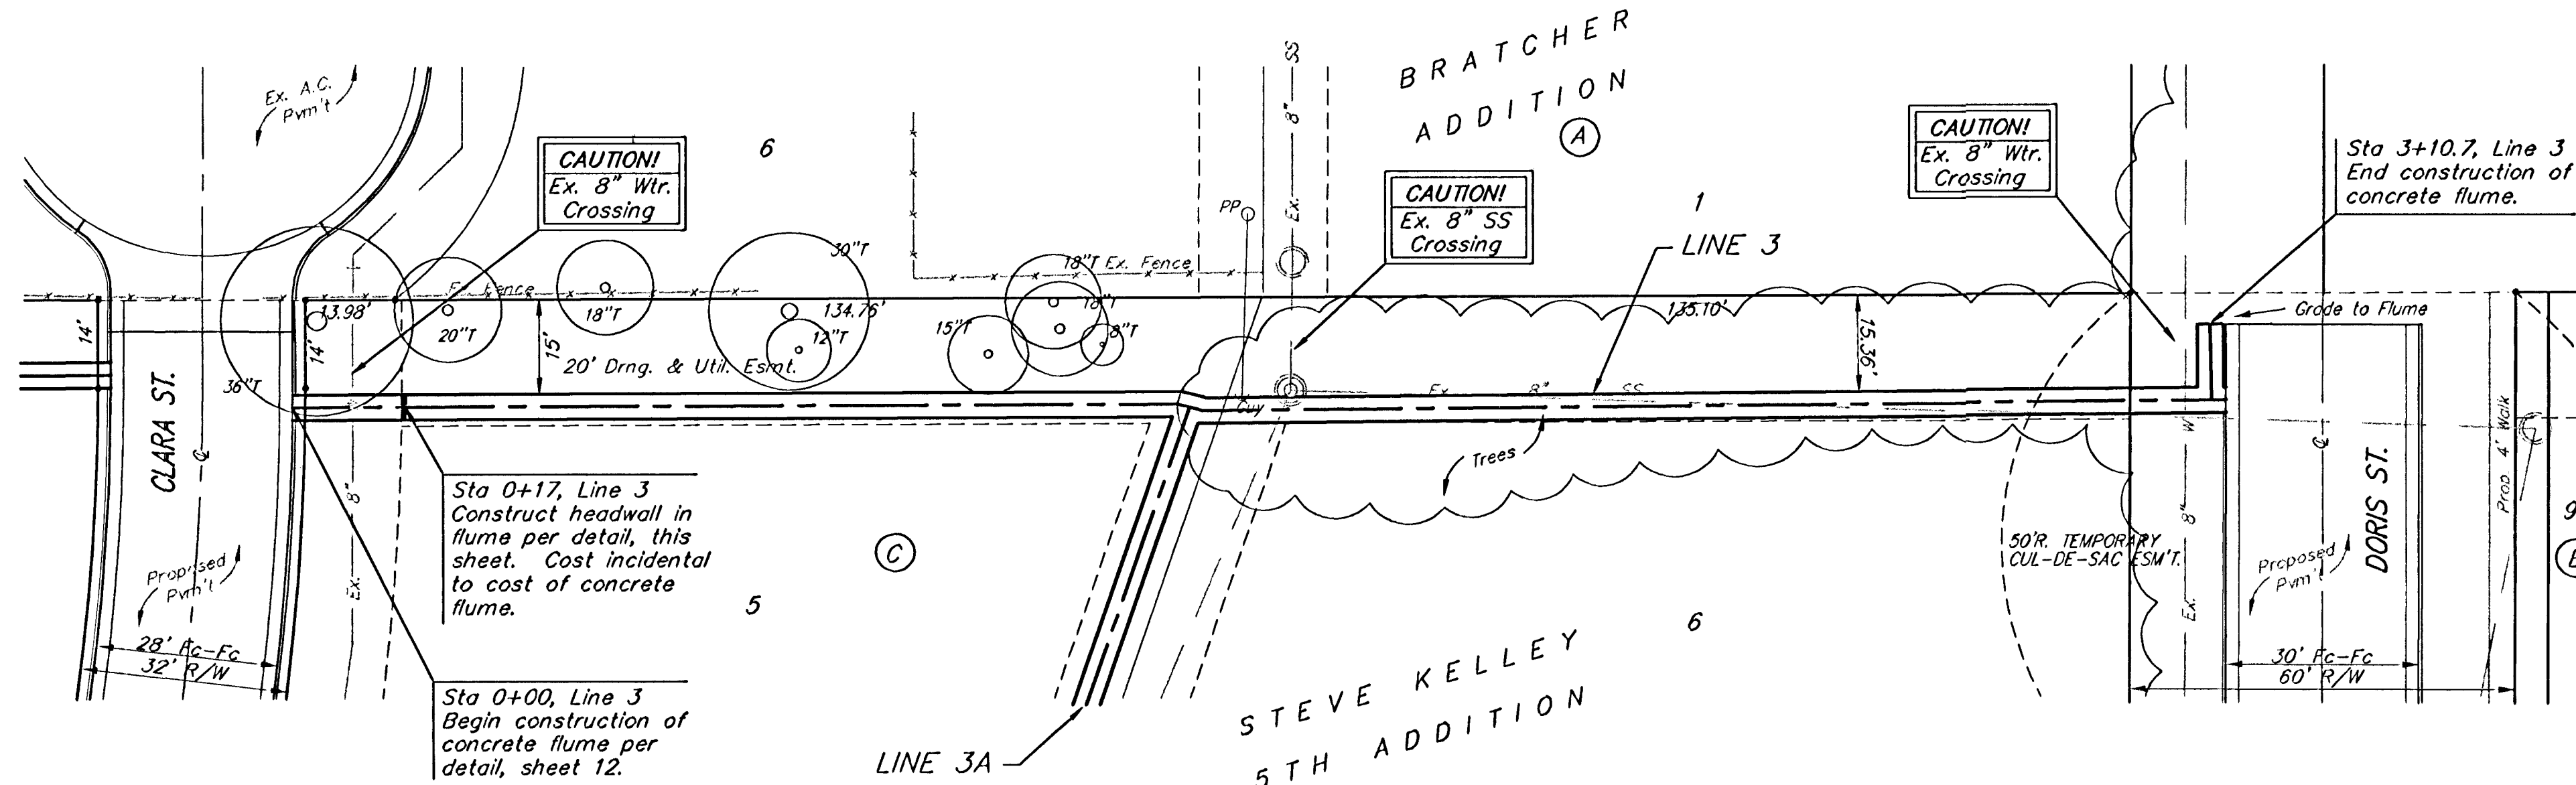
**NOTE:**  
Groove flume longitudinally every  
4 feet. Install expansion joint  
every 100 feet.

Scale: 1" = 20' Horizontal  
1" = 5' Vertical  
• = Iron
