2/14/2020 9:39:15 AM  
BIM 360//198014-003 - Watson Park Events Center New Building/198014\_MASTER  
STRUCT\_R19.rvt

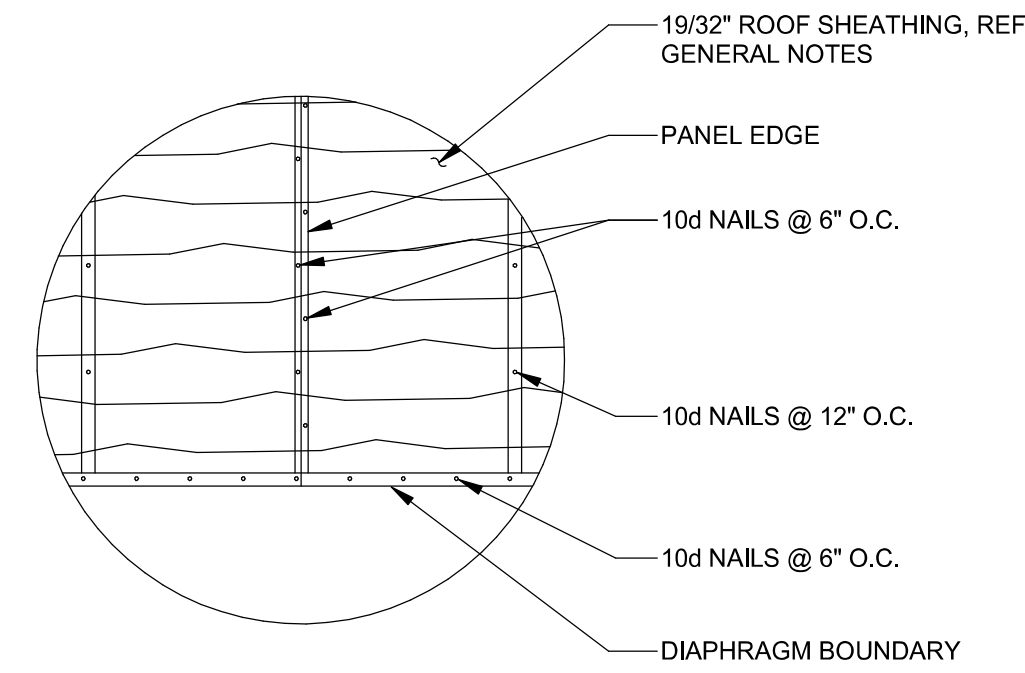
**1 ROOF SHEATHING FASTENING DETAIL**  
NO SCALE

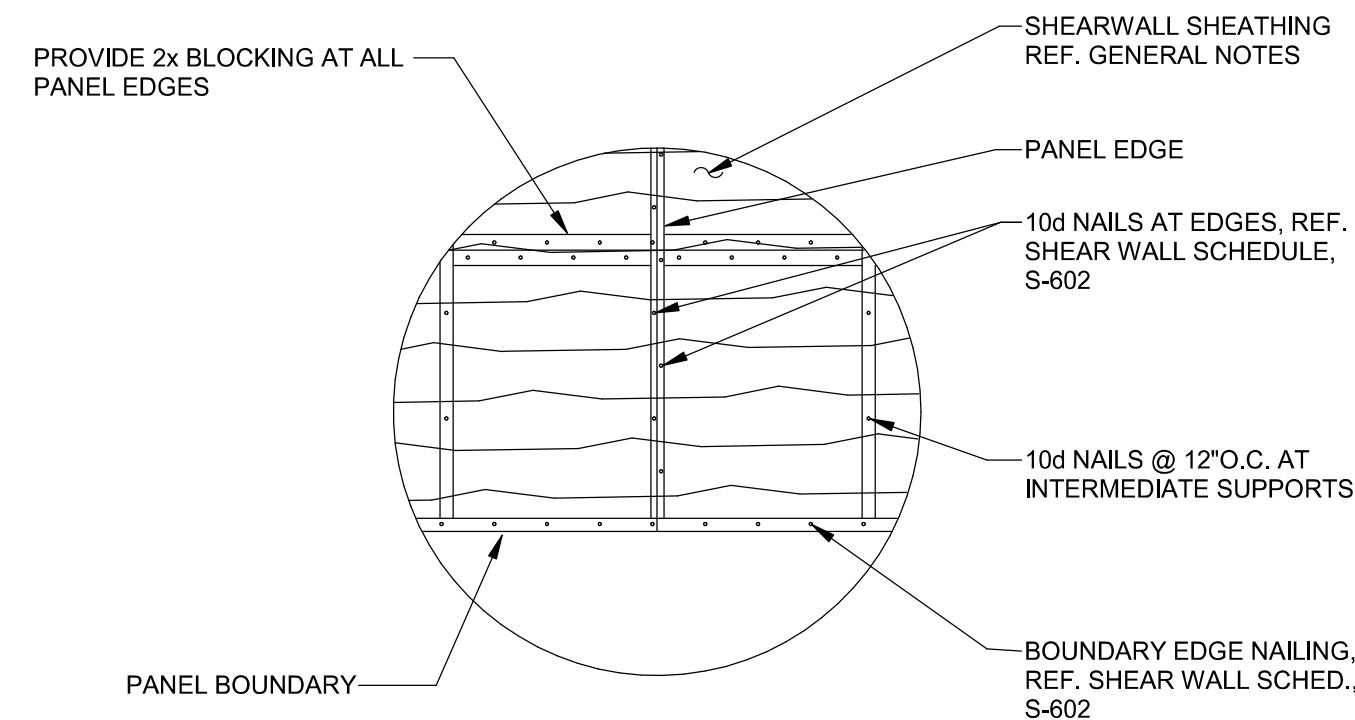
**2 SHEARWALL BLOCKING ATTACHMENT**  
NO SCALE

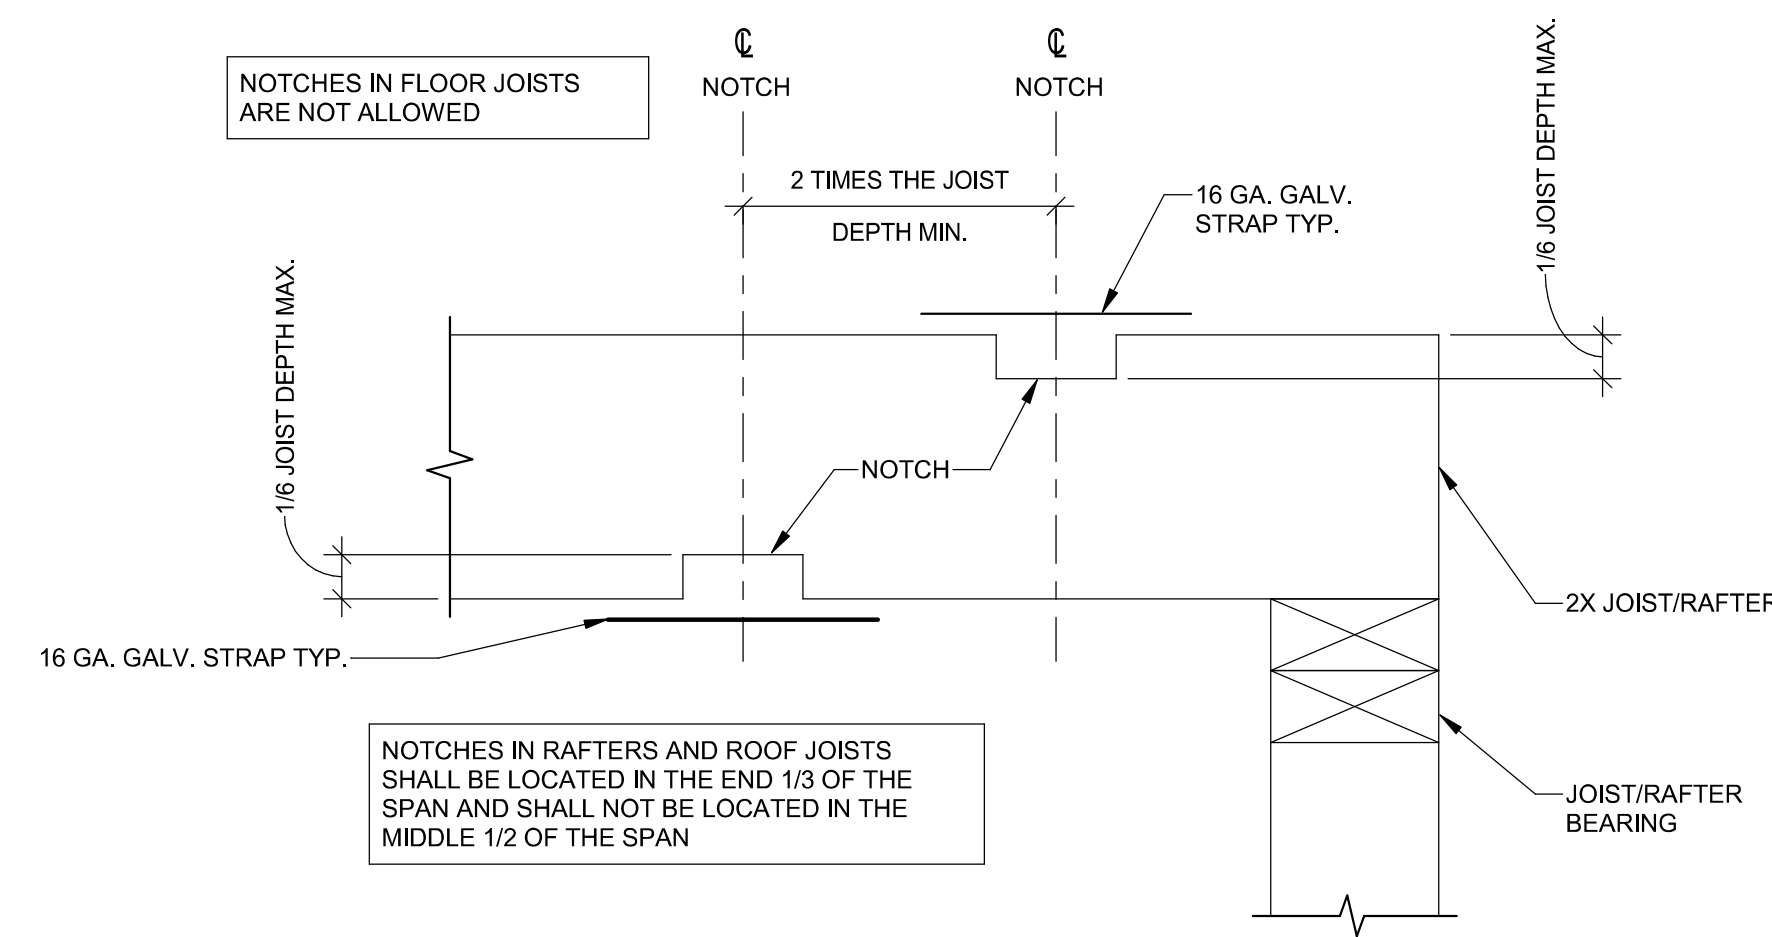
**5 NOTCHES IN THE JOIST/RAFTER**  
NO SCALE

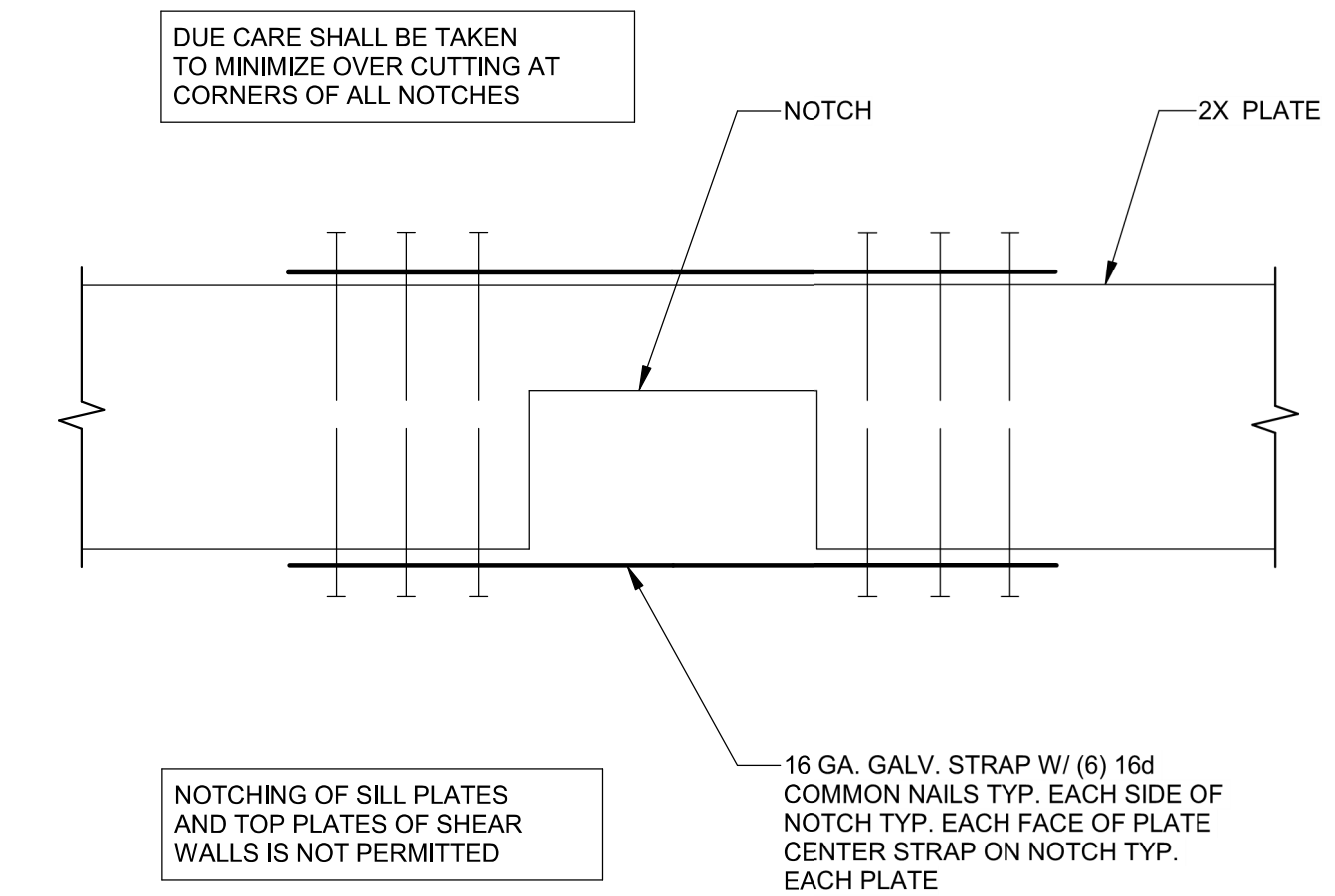
**6 NOTCH IN SILL OR TOP PLATE**  
NO SCALE
