Structure No:	530400870WDCW10
Bridge No:	184
Location:	MOSLEY AT 20TH ST NORTH
Inspected By:	Troy Clark
Date Inspected:	20-Dec-19
Facility Carried:	MOSLEY

2019 Routine Bridge Inspections

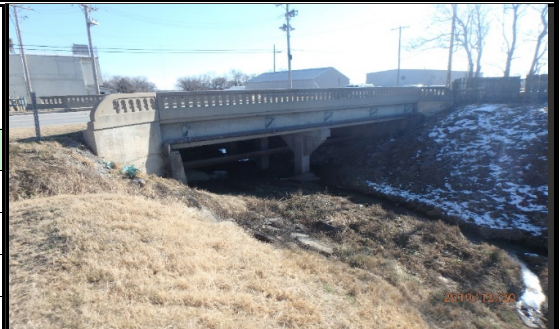
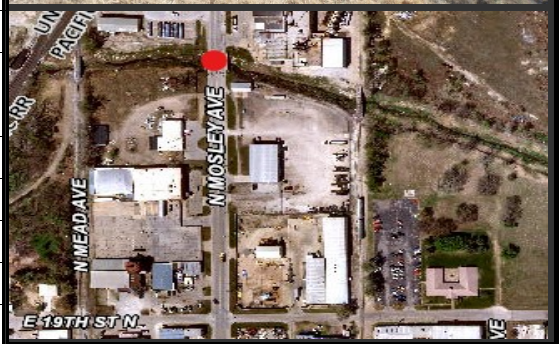
Deck :
 DECK TOP HAS CRACKS THAT HAVE BEEN FILLED AND NUMEROUS PREVIOUS REPAIRS, SOME SPALLING OUT. EAST SIDEWALK HAS AN AREA OF PREVIOUS REPAIR, REPAIR HOLDING. SOUTHEAST CORNER OF HANDRAILING IS SPALLED WITH EXP REBAR, SEE PHOTO. BOTTOM OF DECK HAS SPALLS WITH EXP REBAR AT NORTH ABUT AND AN AREA OF REPAIR AT SOUTH ABUTMENT. 1 ISOLATED SPALL AT MIDPOINT, WEST END SPALL WITH EXP REBAR, APPROX 3 INCHES DEEP. THERE IS A LARGE UTILITY ATTACHMENT HANGING UNDER

Superstructure :
 ALL BEAMS HAVE VARIOUS STAGES OF SPALLING AT ABUTMENT BEARINGS, NO EXP REBAR OBSERVED. ALL BEAMS HAVE VERTICAL OR DIAG CRACKS WITHIN 4 FT OF ABUTMENT FACES. BEAMS OVER PIER LOOK GOOD WITH FEW ISOLATED VERTICAL CRACKS. STEEL BEARINGS HAVE SURFACE RUST WITH SOME AREAS FLAKING.

Substructure :
 ABUTMENTS HAVE MINOR SCALING, AND VERTICAL CRACKS. PIER CAP HAS NO VISIBLE DEFECTS. COLUMNS LOOK GOOD WITH ISOLATED HL CRACKS ONLY.

Channel :
 CHANNEL IS STEEP, GRASS LINED. HEAVY TRASH UNDER NORTH SPAN.

<u>Maintenance Recommendations</u>	
CONCRETE PATCHING TOP OF DECK, BRIDGE RAIL REPAIR
